Double Pipe Creek Watershed Stream Corridor Assessment

Winter 2016

**Prepared By
Carroll County Bureau of Resource Management**

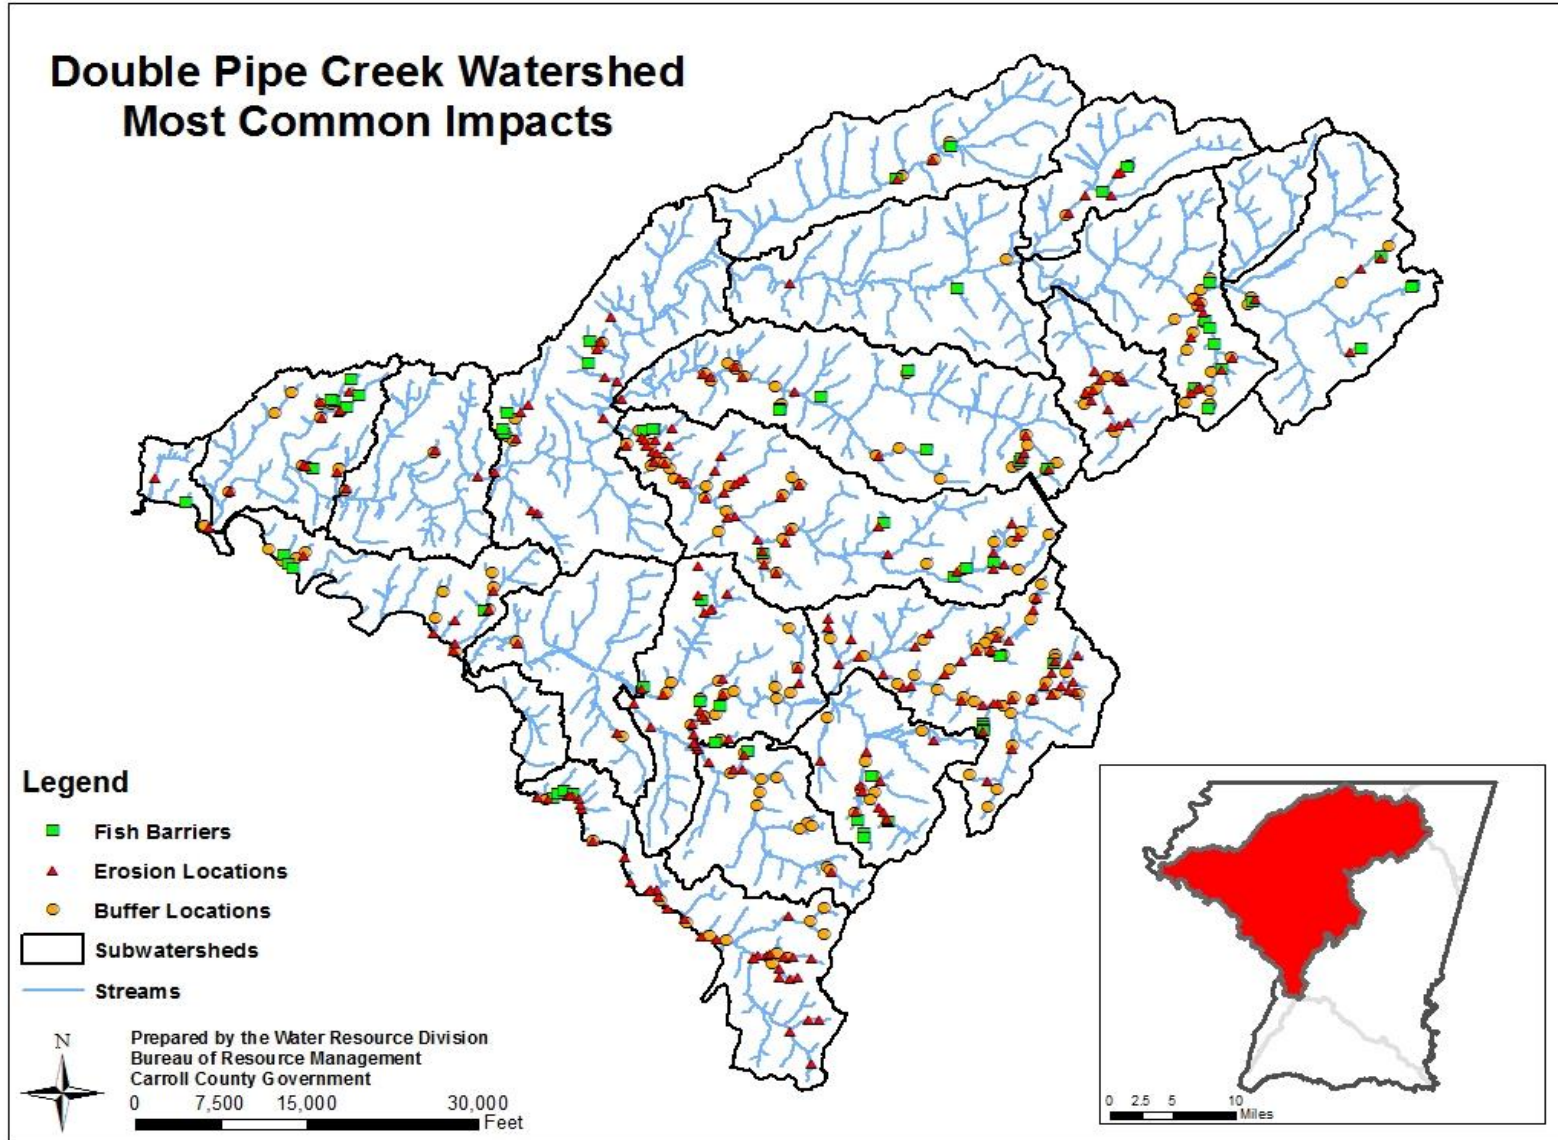
Figure 1-3: Most Commonly Identified Impacts

A total of 944 data points were collected across the watershed. Inadequate buffers and stream bank erosion were the most frequently identified problems. Drainage pipe outfalls and fish barriers were also regularly present throughout the watershed. Table 1-2 lists the data points by severity across the entire watershed. The most commonly identified impacts are shown in Figure 1-3 and Table 1-3 presents a summary of the number of impacts identified in each subwatershed. Criteria for ranking each impairments severity can be found in Appendix B.

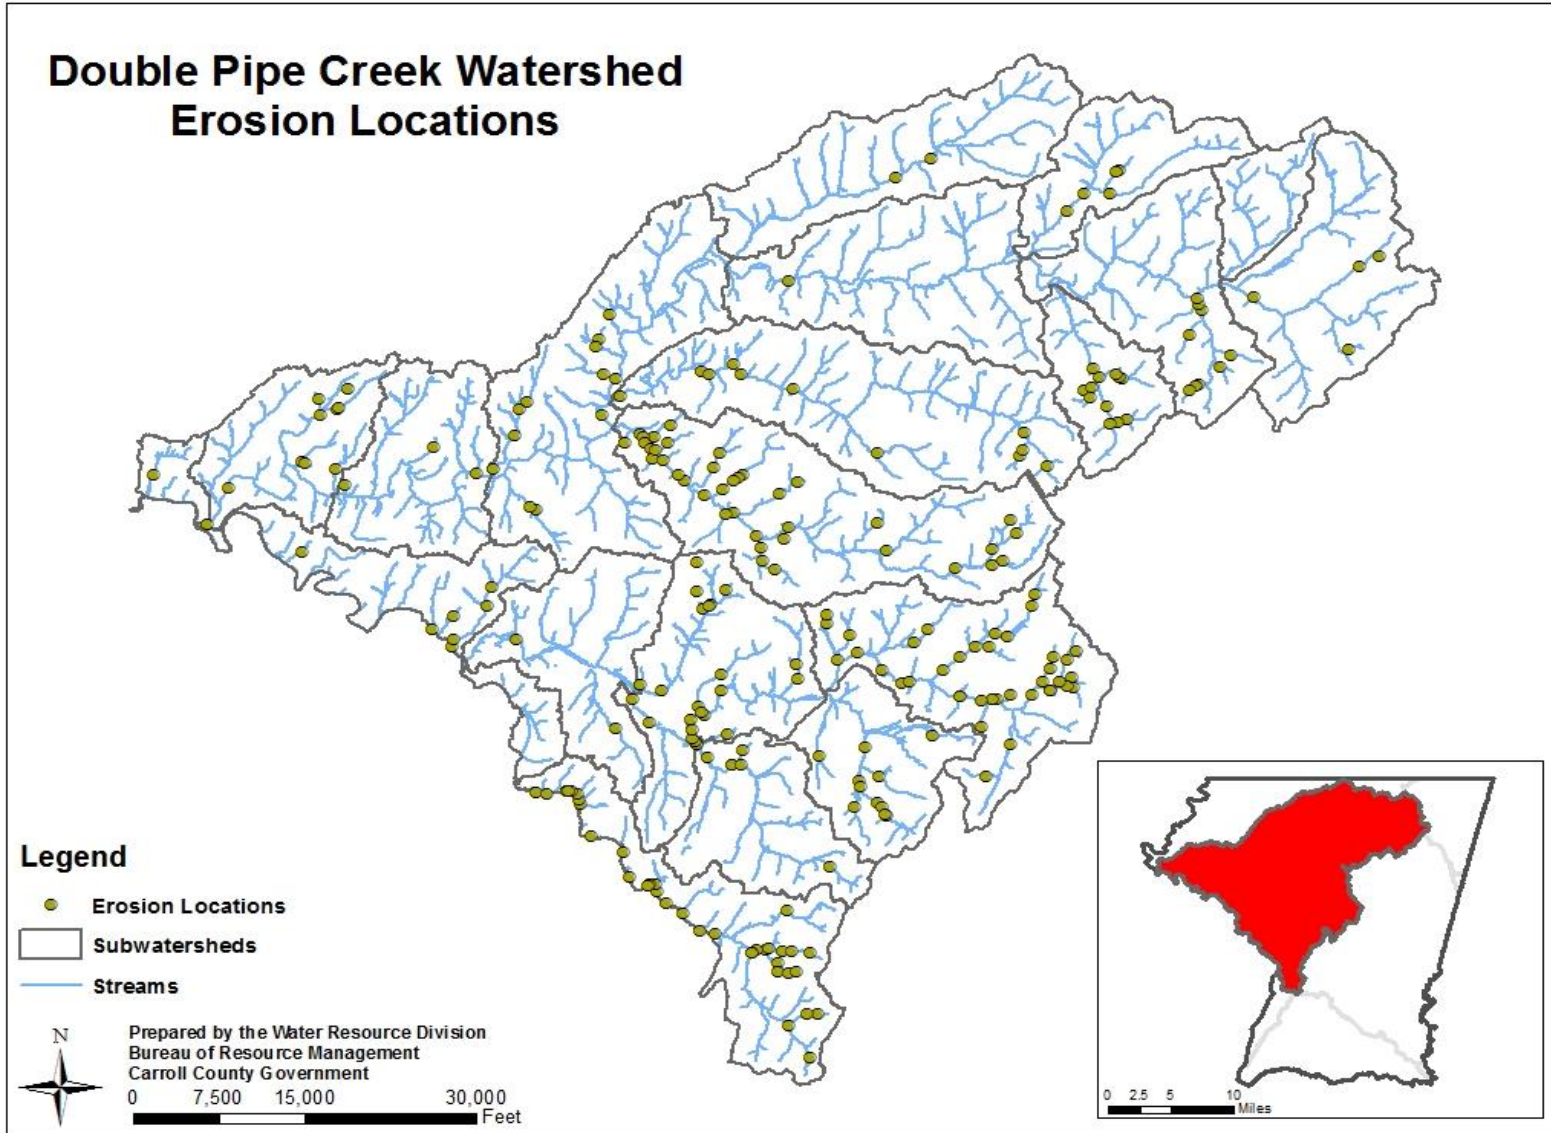
Figure 1-4: Erosion Locations

The most common problem identified through the Stream Corridor Assessment was erosion. A total of 40 miles (23.5%) of the 170 miles assessed were found to have an erosion problem, with approximately 14 percent of the assessed stream length categorized as having a severe or very severe erosion problem. Figure 1-4 shows the location of active erosion sites identified during the Stream Corridor Assessment.

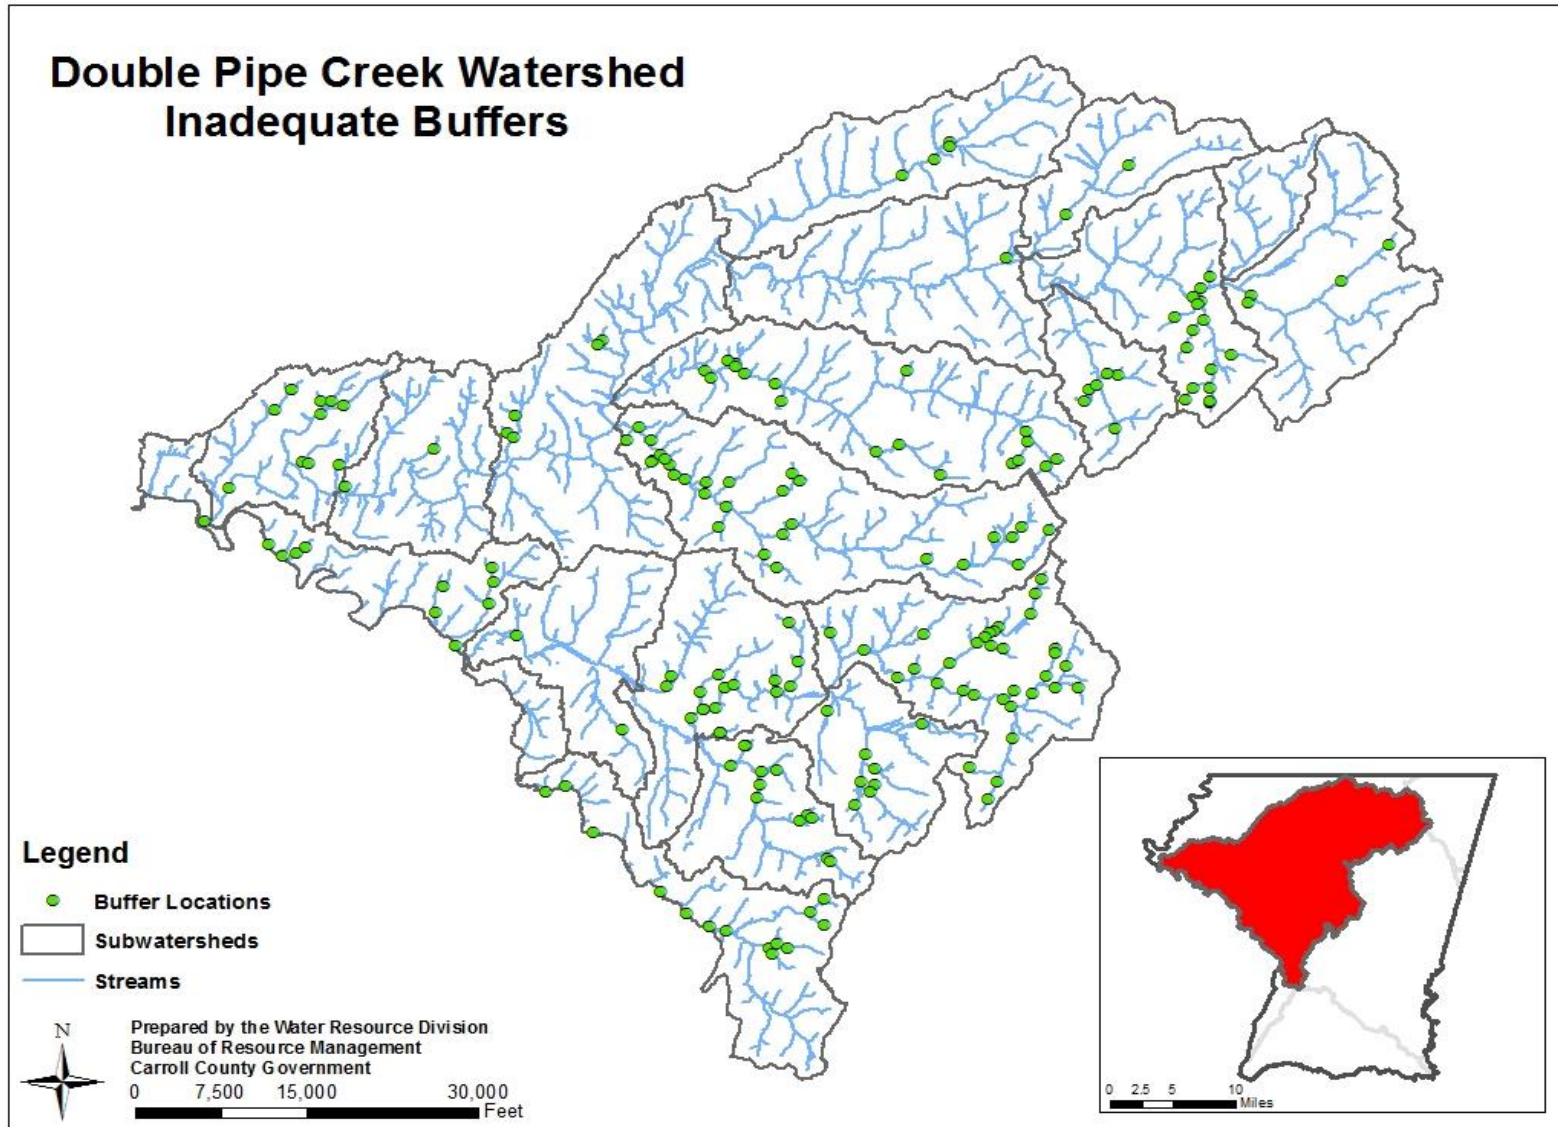
Figure 1-5: Inadequate Buffers

Buffer areas were identified as inadequate for 42 miles (25%) of the streams assessed, with 17 percent of the assessed stream length classified as severely or very severely un-buffered. 108 of the sites identified both sides of the stream as completely unshaded, and livestock was noted to be present at 34 different sites. Of the 234 sites identified, 21 had been recently planted but were not yet established. Figure 1-5 shows the location of identified inadequate buffers.

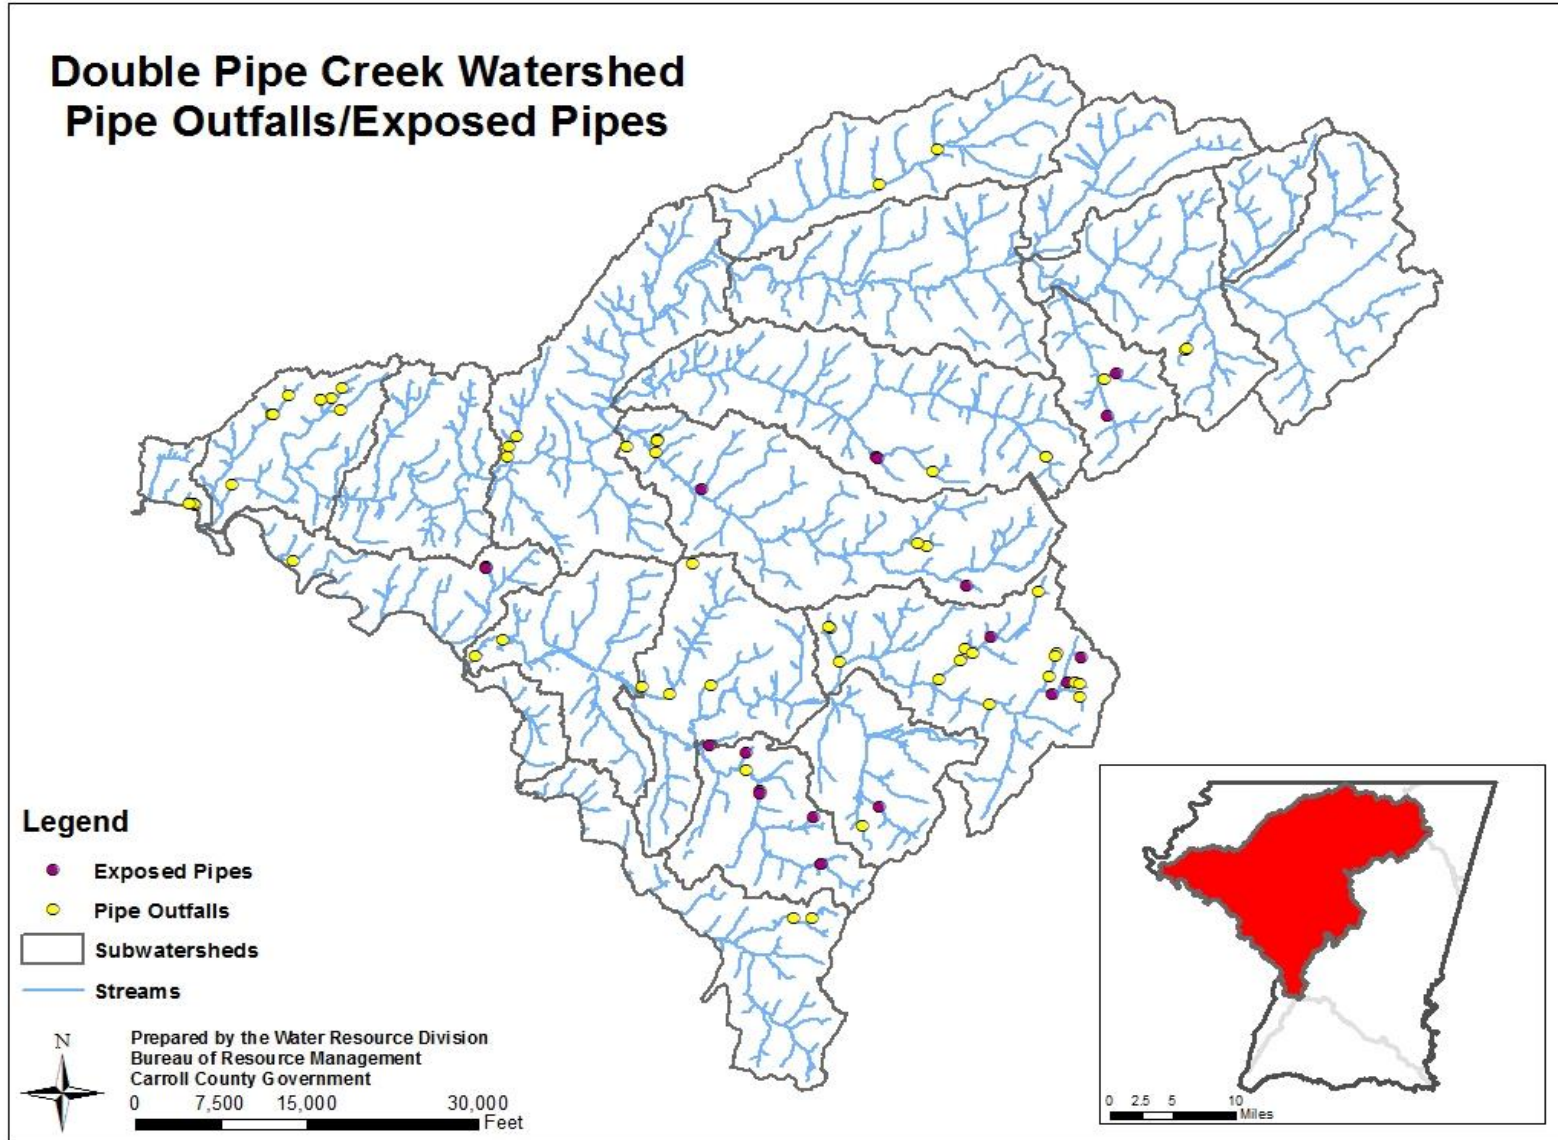
Figure 1-6: Pipe Outfalls and Exposed Pipes

Outfalls were found throughout the entire watershed, but the highest concentrations were located in the Little Pipe Creek (0276) subwatershed. This higher concentration can be attributed to the city of Westminster, which makes up the headwaters of this subwatershed. The majority of the outfalls identified were 6" or less in diameter and were given a low impact rating. The location of identified pipe outfalls can be found in Figure 1-6.

Exposed pipes were identified at 20 different locations within the watershed, with the majority being concentrated around the Cities of Westminster and New Windsor. Any exposed pipe identified during the SCA is reported to the appropriate public works department for additional investigation.

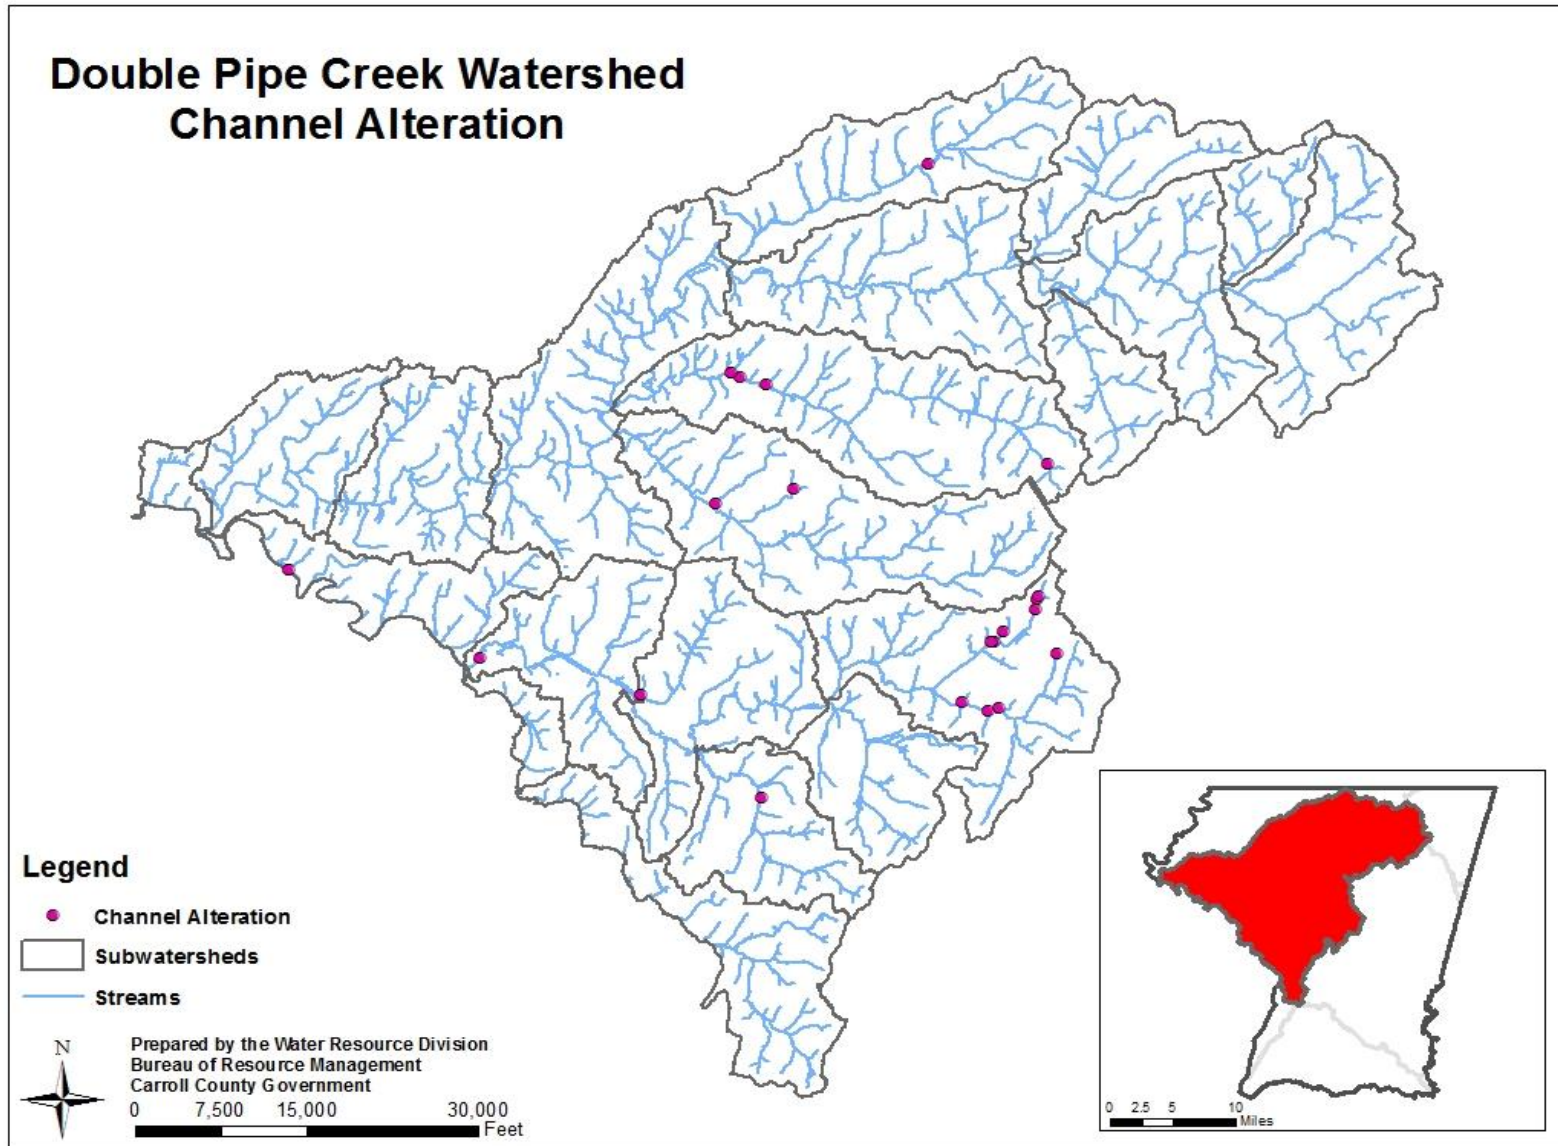
Figure 1-7: Channel Alteration

Impacts from channel alterations were found at 21 different sites within the watershed and totaled 4,659 linear feet. The vast majority of alterations identified were associated with the protection of infrastructure and were given a minor severity ranking. Figure 1-7 shows the location of identified channel alterations within the watershed.

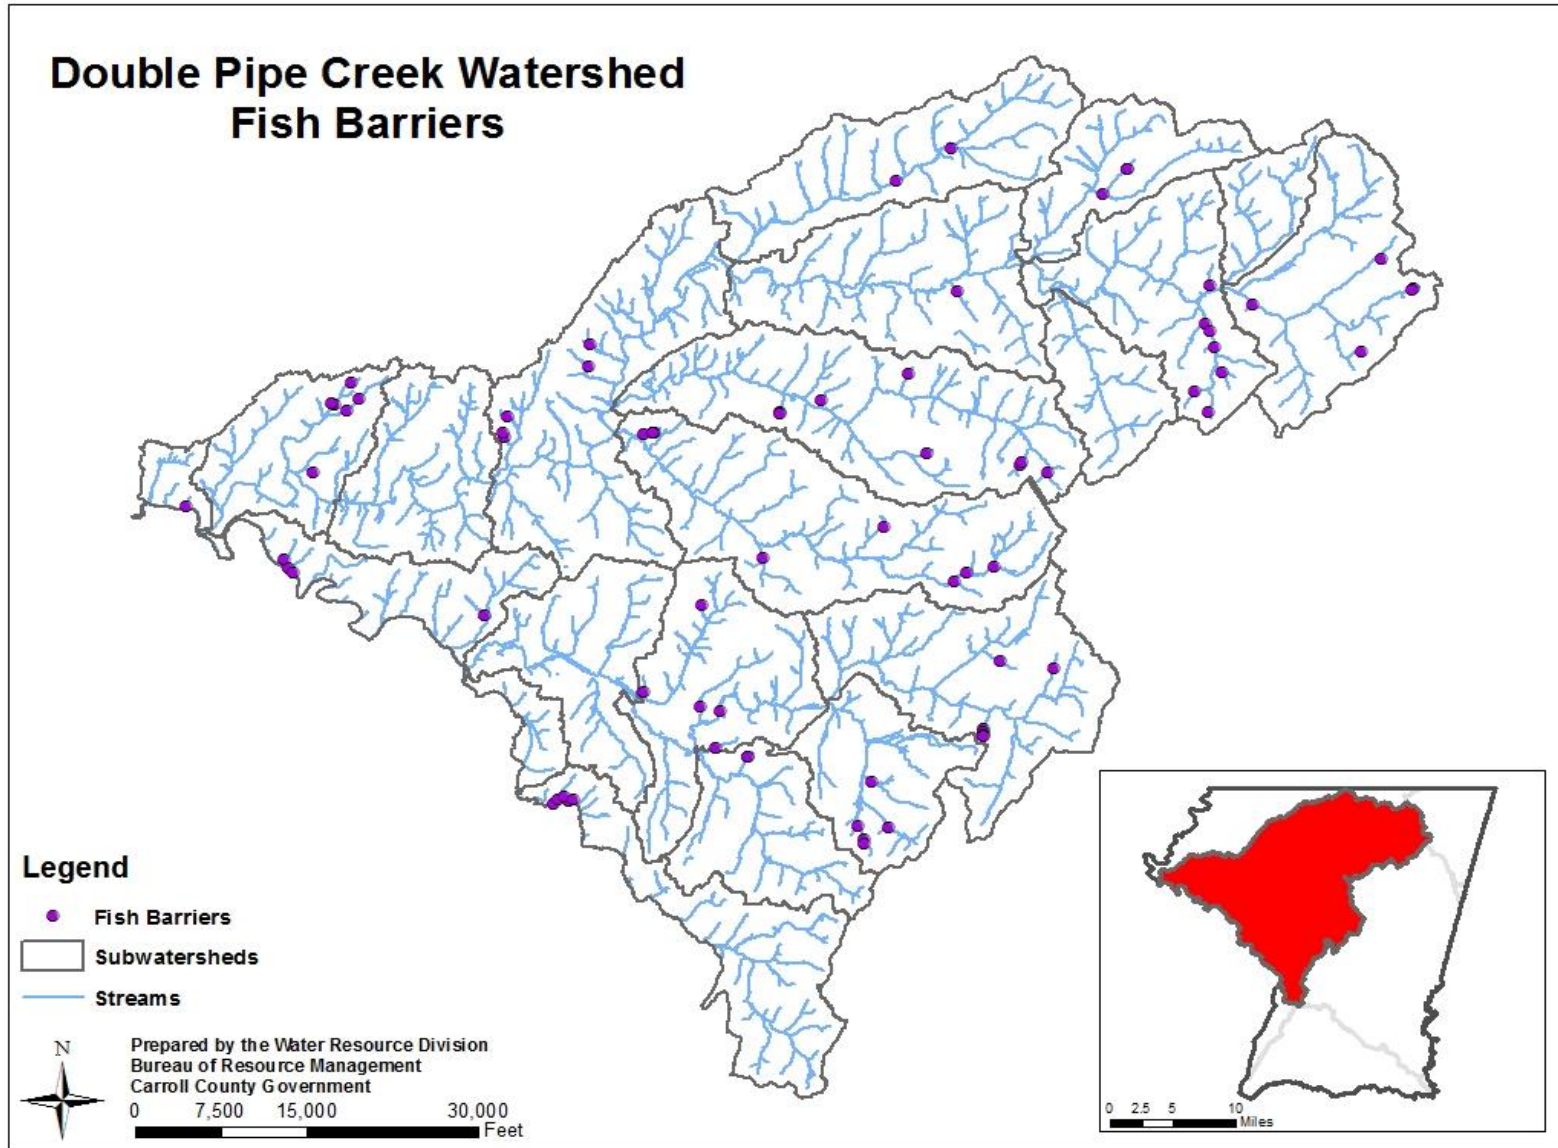
Figure 1-8: Fish Barriers

There were 74 fish barriers identified during the survey; all of the sites were associated with temporary debris dams, perched road culverts, or natural falls. 34 of the identified sites significantly restricted upstream fish movement and received a moderate or worse severity rating. Figure 1-8 shows the location of identified fish barriers.

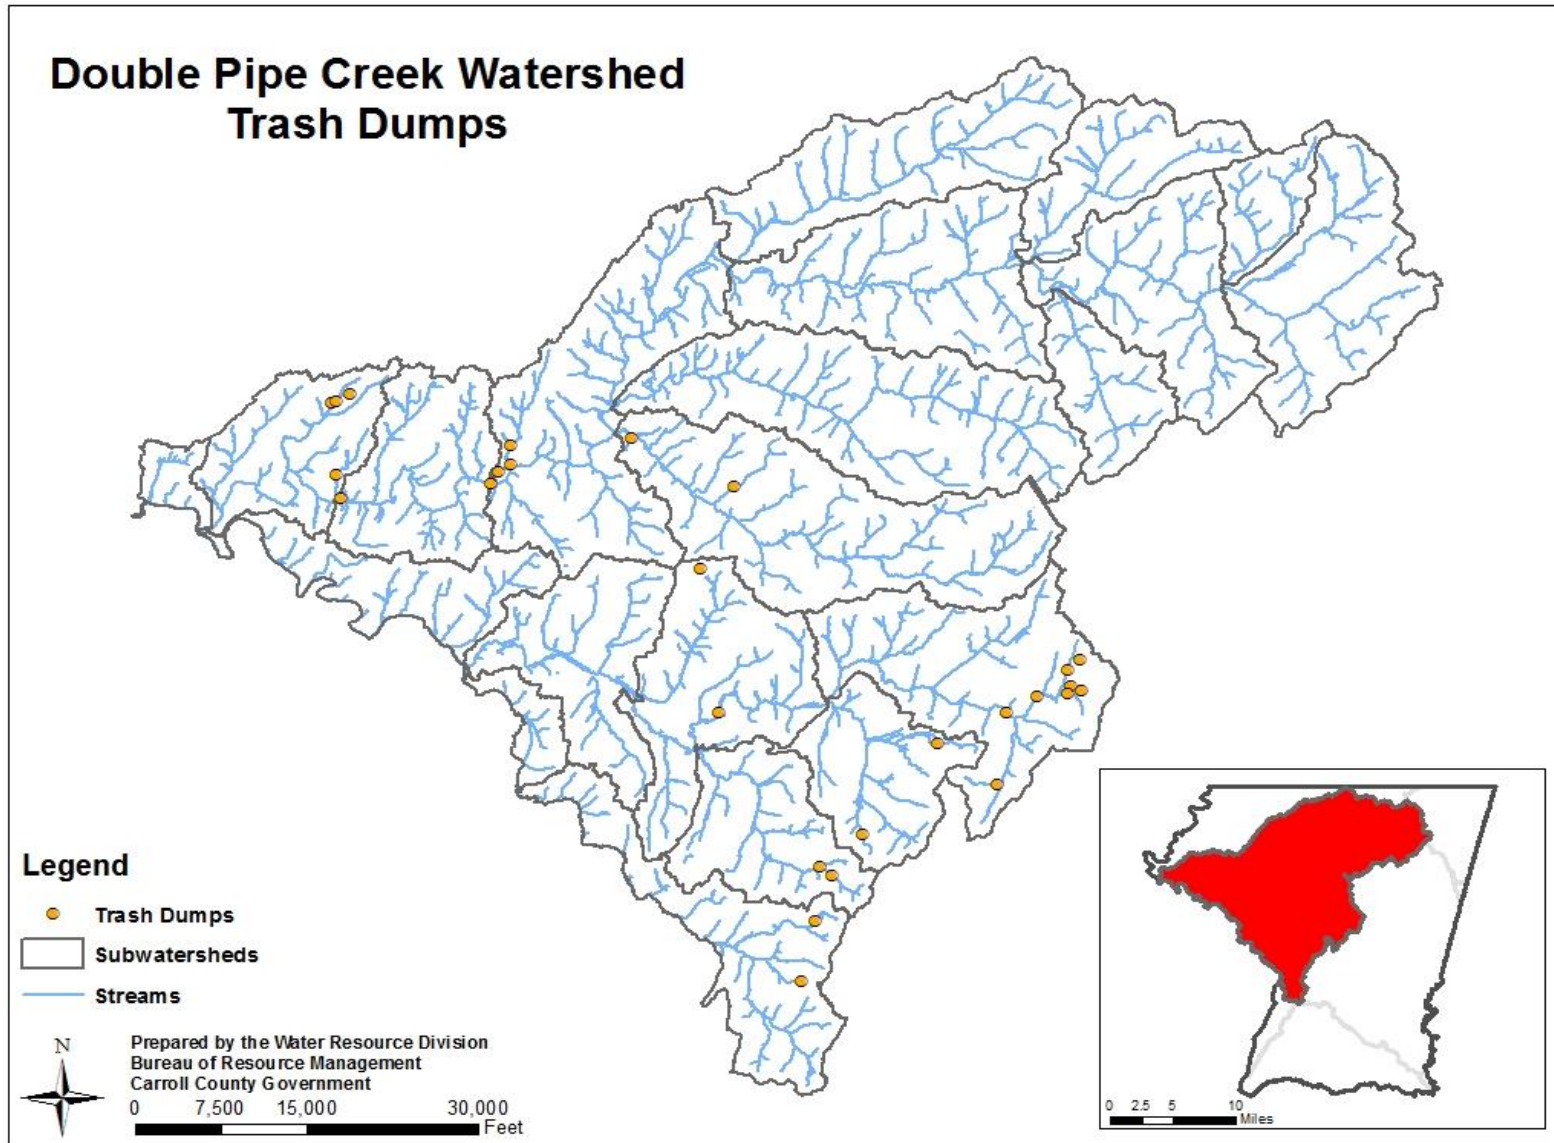
Figure 1-9: Trash Dumps

Impacts from trash were minimal with 27 identified locations within the watershed; most of the sites had a moderate to minor severity rating. Five sites had a severe or very severe rating with the largest site estimated to have approximately 30 truckloads of waste. The location of identified trash sites can be found in Figure 1-9.

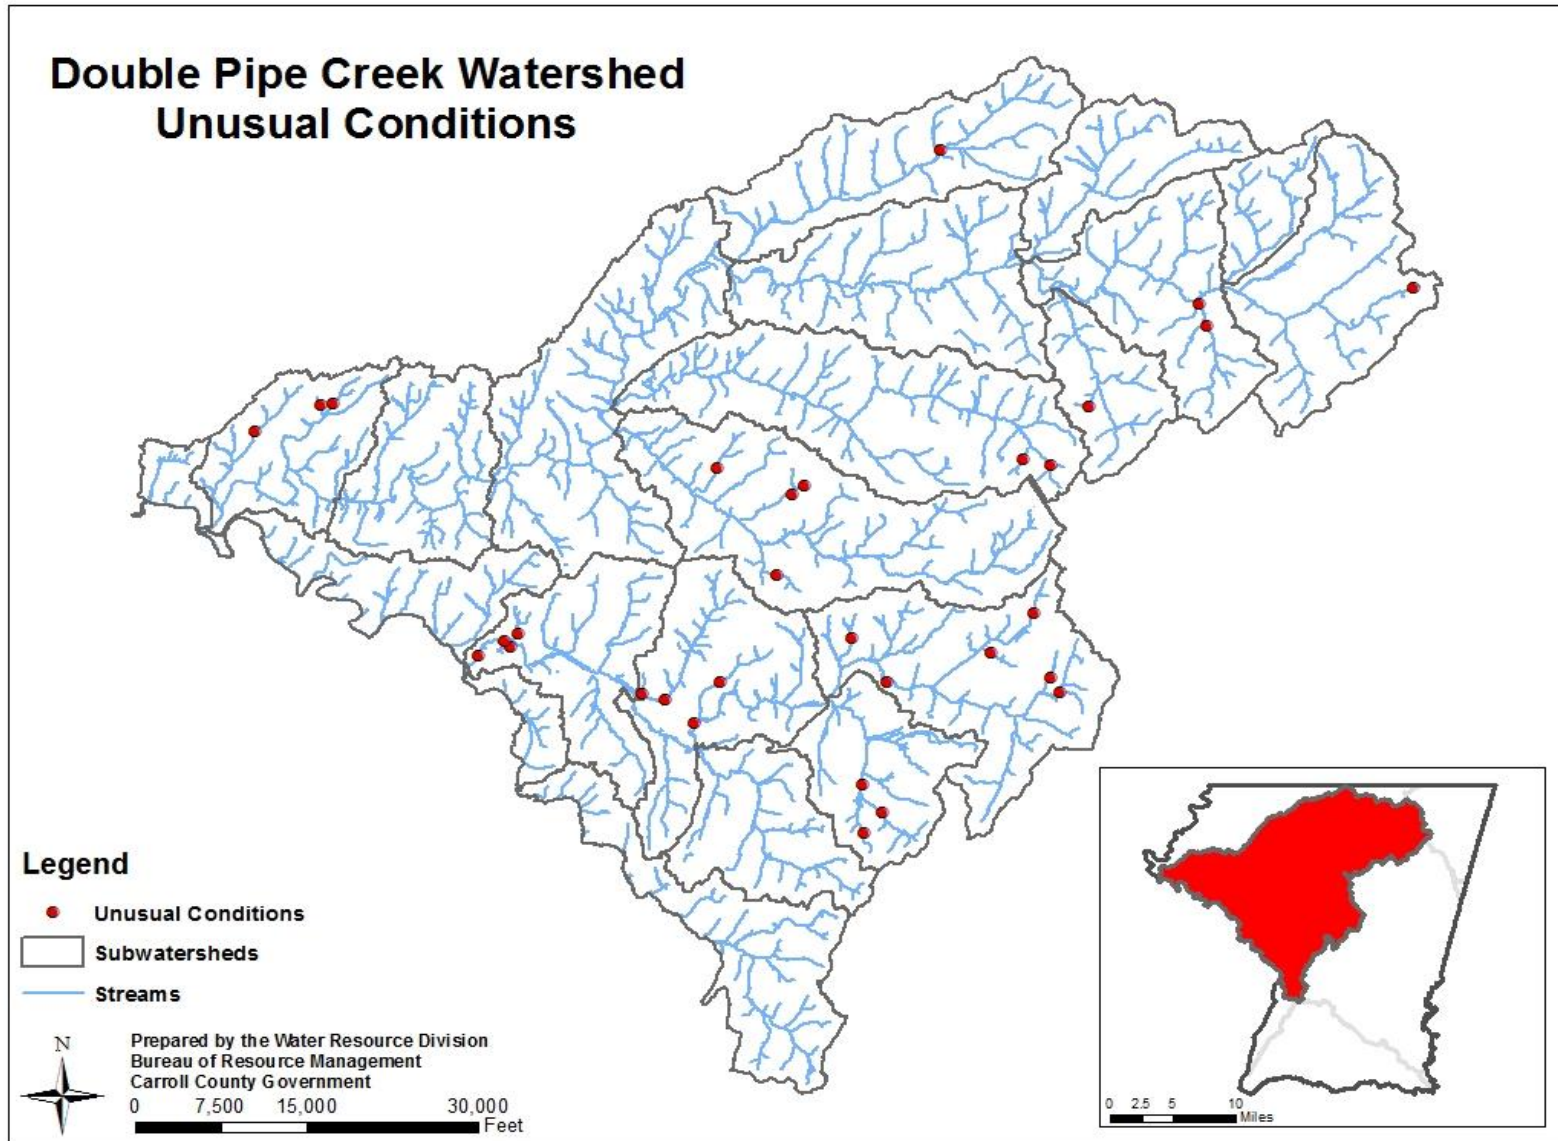
Figure 1-10: Unusual Conditions

Field crews identified 31 unusual conditions during the assessment. The majority of the unusual conditions were comment based, noting or describing something out of the ordinary. Excess algae was the most common unusual condition noted. The location of these can be found in Figure 1-10.
