Carroll County Maryland

**NATIONAL POLLUTANT DISCHARGE ELIMINATION SYSTEM
MUNICIPAL SEPARATE STORM SEWER SYSTEM
DISCHARGE PERMIT**

2016 ANNUAL REPORT

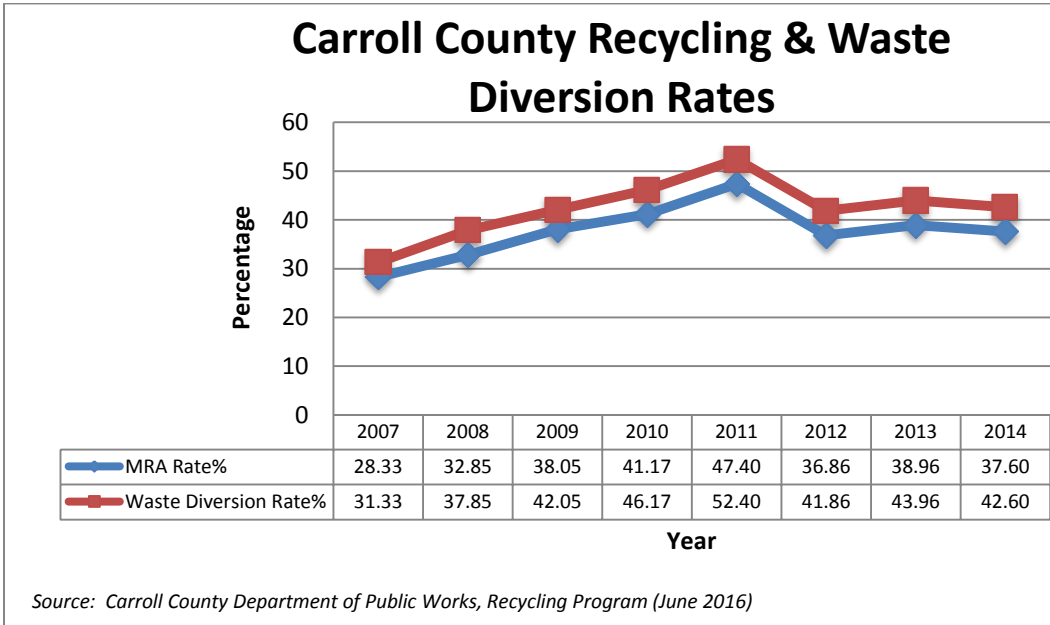
Figure 3: Carroll County Recycling & Waste Diversion Rates

Figure 3, “Carroll County Recycling & Waste Diversion Rates,” shows the rate of MRA recycling as well as the waste diversion rate. The source reduction credit is reflected in the waste diversion rate (added to the recycling rate).

Figure 2, “Carroll County MRA Recyclables,” and **Figure 3**, “Carroll County Recycling & Waste Diversion Rates,” demonstrate the trend in both the recycling weight and rates, respectively, in Carroll County from 2007 to 2014 (2015 data not yet published by MDE). Recycling of MRA recyclables in Carroll County rose steadily from the start and expansion of the program in 2007 and 2008; however, falling oil prices, a strong U.S. dollar, and a weakened economy in China have caused the national and global industry to take a significant downturn since 2011, which have impacted Carroll’s recycling market as well. These market conditions, which are beyond the County’s control, have subsequently impacted Carroll’s recycling rates for MRA recyclables. Although the County is currently paying to dispose of the recyclables, the County continues to encourage recycling to reduce the waste stream to the landfill, and the recycling rate since 2012 is on the rise.

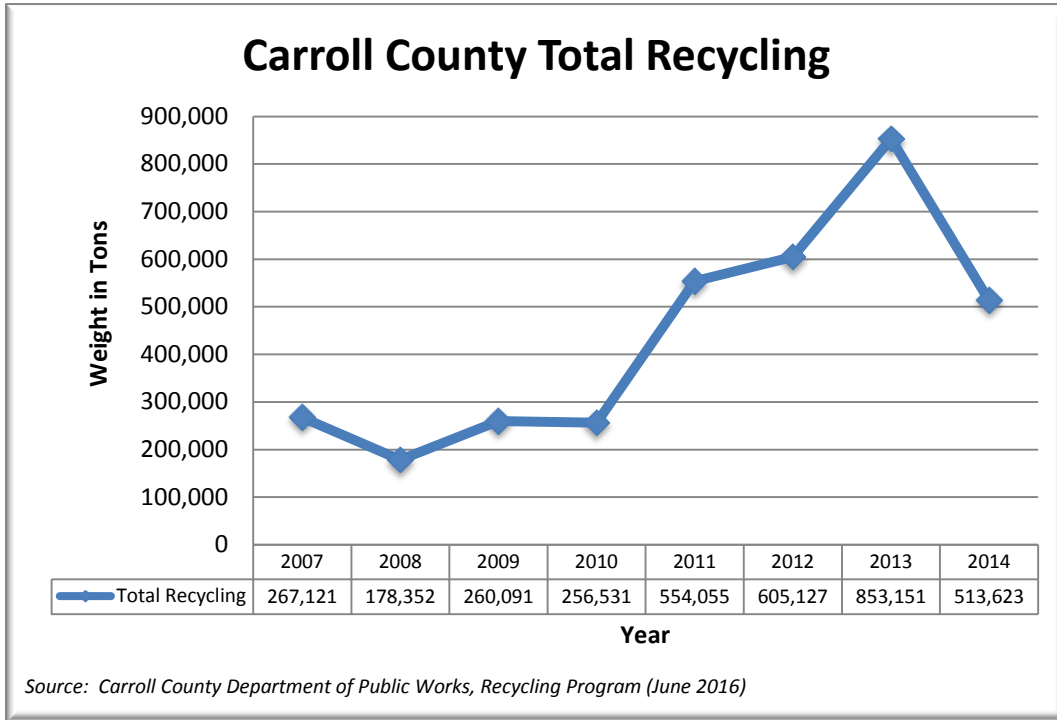
Figure 4: Total Recycling

Non-MRA recyclables may include automobile components, construction/building materials, and other materials. The County’s MRA recycling rate has decreased since 2011, which is subsequently reflected in the drop in total recycling from 2013 to 2014. However, overall, the County’s total recycling still reflects an increase between 2007 and 2014 and is still meeting the 35 percent recycling rate required by the MRA (see **Figure 4**). This success continues to divert

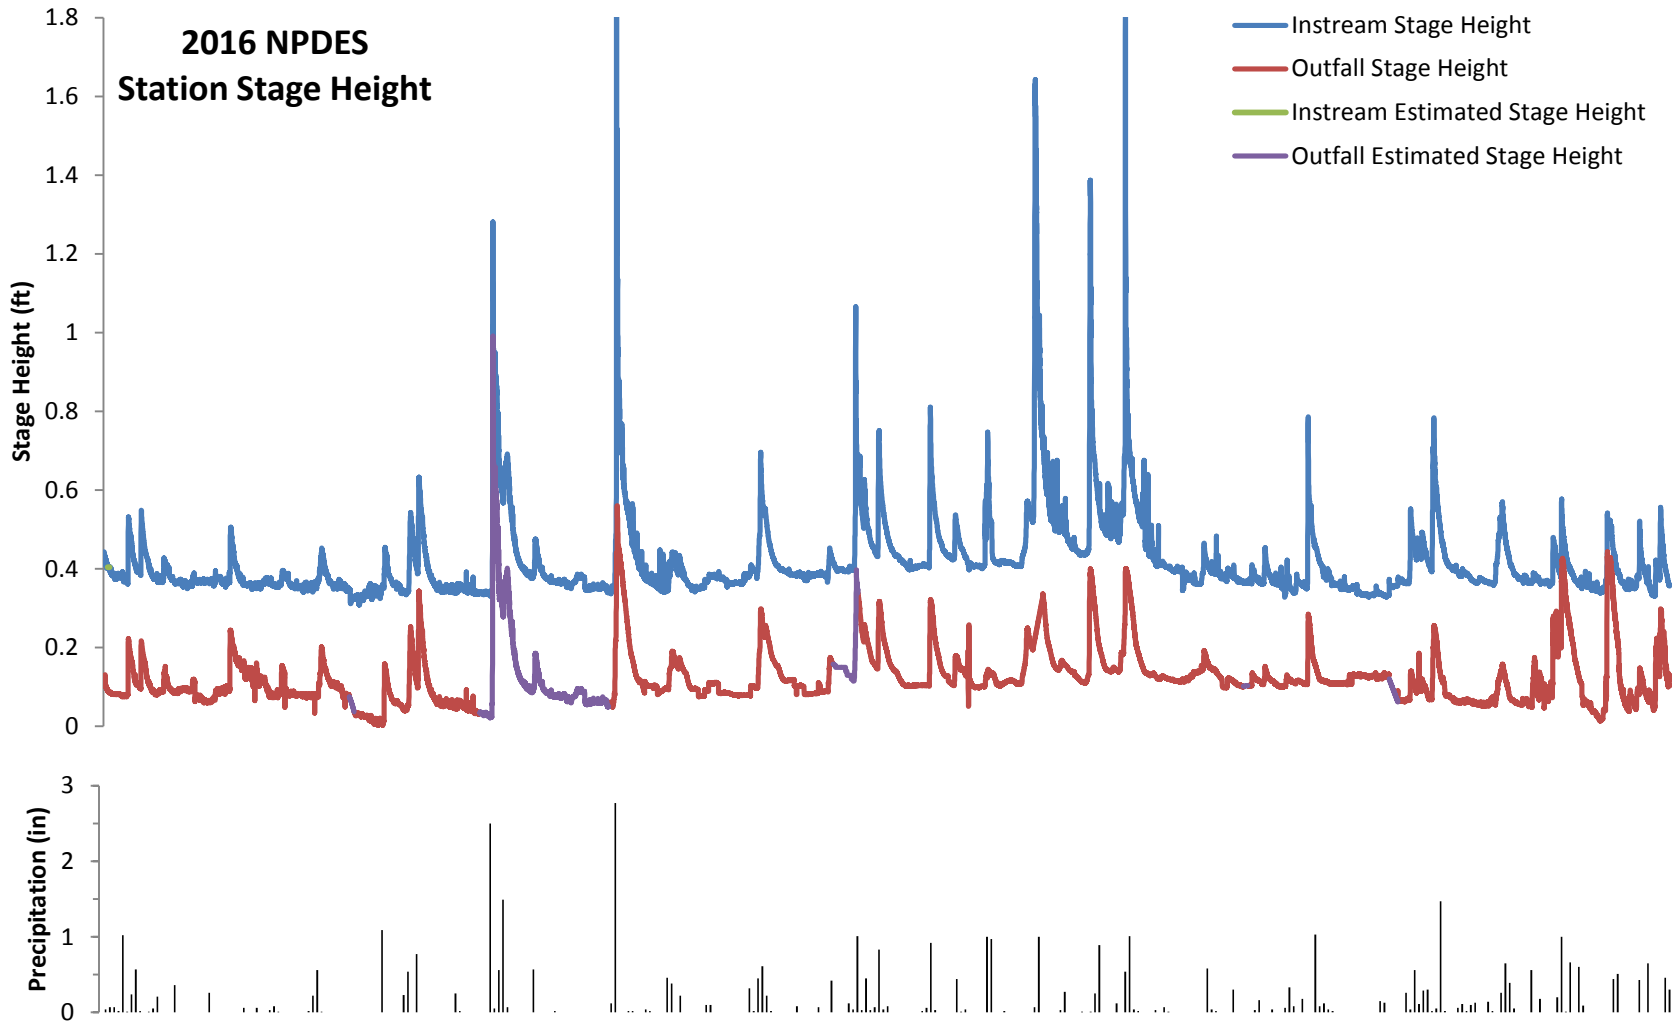
Figure 12: Stage Heights and Daily Precipitation for NPDES Monitoring Stations for the 2016 Reporting Year

Typical stage heights observed for the instream monitoring station were approximately 0.38 feet, or 353 gpm. During the October 27-28, 2015, and February 24, 2016, storm events, stage height reached the peak for the reporting year at almost 1.9 feet. The resulting discharge was 19,000 gpm. There were 4 other storm events during this time where stage heights above 1 foot (6,600 gpm) were observed. These occurred on September 30, 2015, December 23, 2015, February 3, 2016, and February 16, 2016, with stage heights of 1.28, 1.07, 1.64, and 1.39, respectively.

Please note that stage heights and discharges from both stations were periodically estimated. These data were lost due to equipment failure.

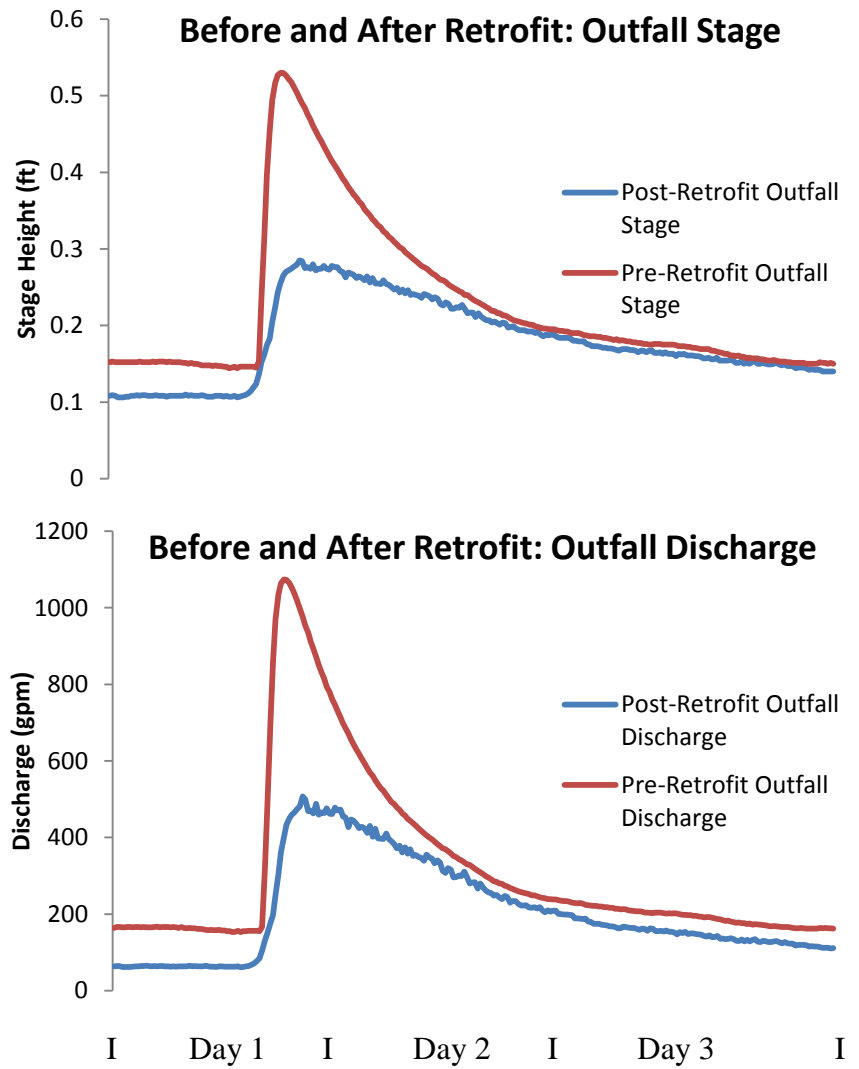
Figure 15: Characteristics of Analogous Storms Pre-Retrofit (7/23/2006, 0.39”) and Post-Retrofit (4/7/2016, 1.03”)

Looking at individual components of the hydrograph allows one to observe the distinct mechanism behind any changes in cumulative frequencies throughout the year. **Figure 15** represents 2 analogous storm events, one before and one after the stormwater retrofit, and a hydrological comparison therein. This figure contains hydrographs before and after retrofit for instream and outfall stage heights and discharges. Unlike previous years, which compared storm events with nearly identical precipitation totals, this comparison is of a significantly larger storm event to the same pre-retrofit storm.

The pre-retrofit event had 0.39 inches of precipitation observed while the post-retrofit event had 1.03 inches of precipitation observed. Despite the higher precipitation total and intensity, the ascending limb for the post-retrofit outfall station still had a lower slope and peak discharge than the hydrograph of the pre-retrofit outfall station with a smaller storm event. The outfall to instream station discharge ratio for the post-retrofit storm event maintained a ~27 percent contribution, as was roughly the case for the overall discharge and separated stormflow for the reporting period. During the pre-retrofit storm, however, the outfall station contributed ~70 percent of the total instream discharge. The lesser contribution during the post-retrofit storm event is evident in the instream station hydrographs. The post-retrofit storm event at the instream station has a higher volume discharged than that of the pre-retrofit storm, even with less volume discharged from the outfall station. The period of baseflow recession after the storm event was much shorter during the pre-retrofit storm as well. Overall, longer baseflow recessions and lower peak discharges were observed with the current stormwater configuration.

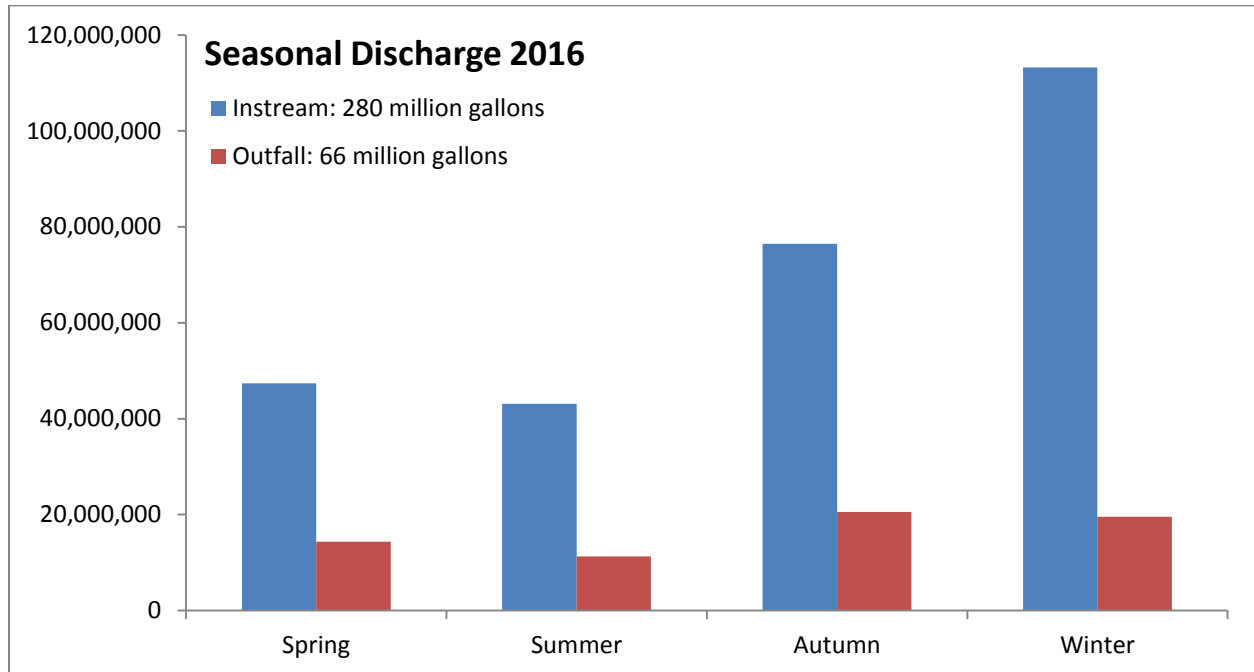
Figure 21: Seasonal Discharge for the 2016 Reporting Year

total load occurring during that season. The outfall station consistently correlates to values estimated for the instream station.
