Cascade Lake Dam Breach and Restoration

Cascade Lake

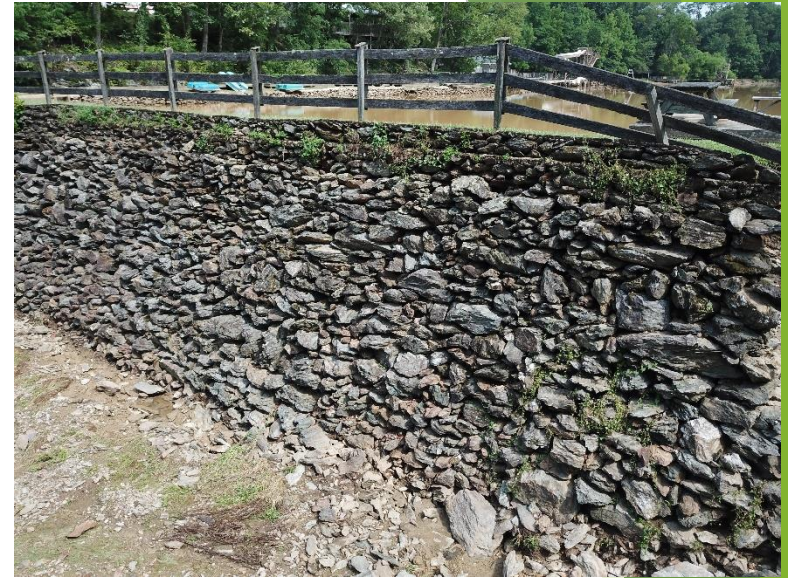
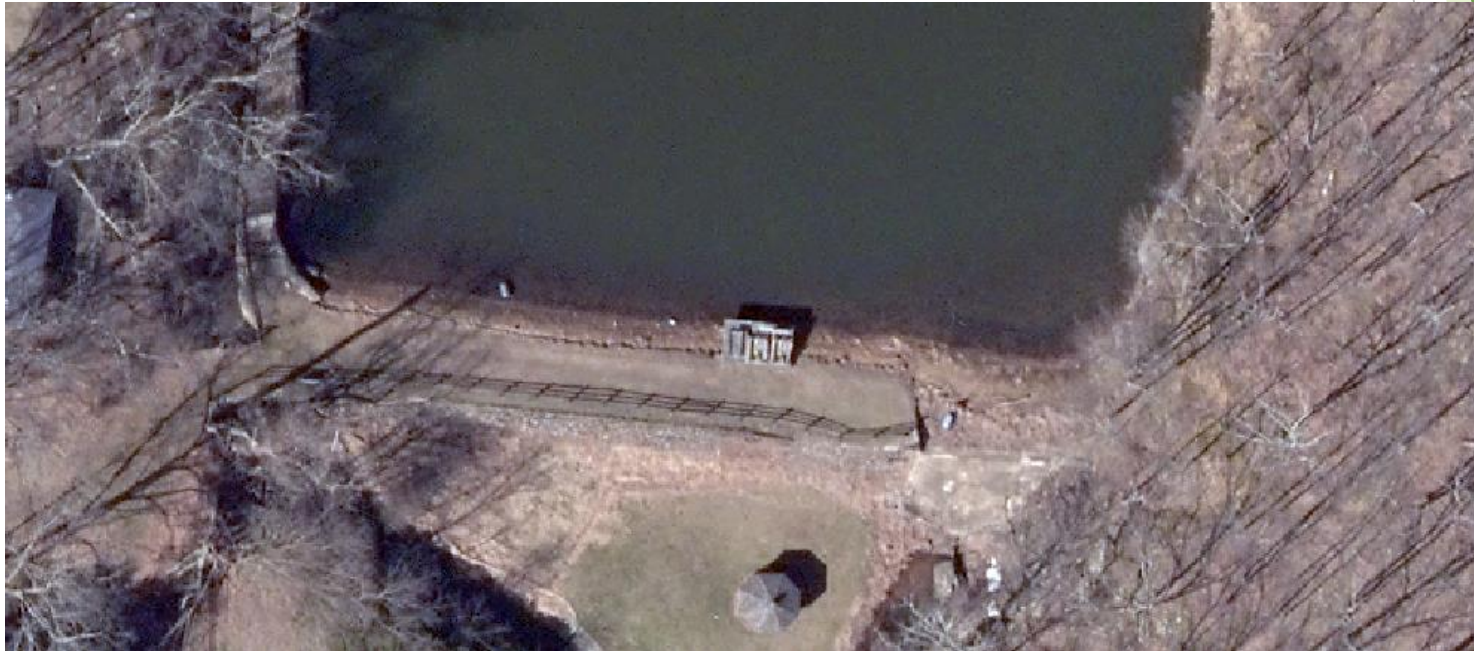
- ▶ Purchased by current owners in 1992
- ▶ Mill removed in 1994
- ▶ 14 feet high
- ▶ 220 feet wide

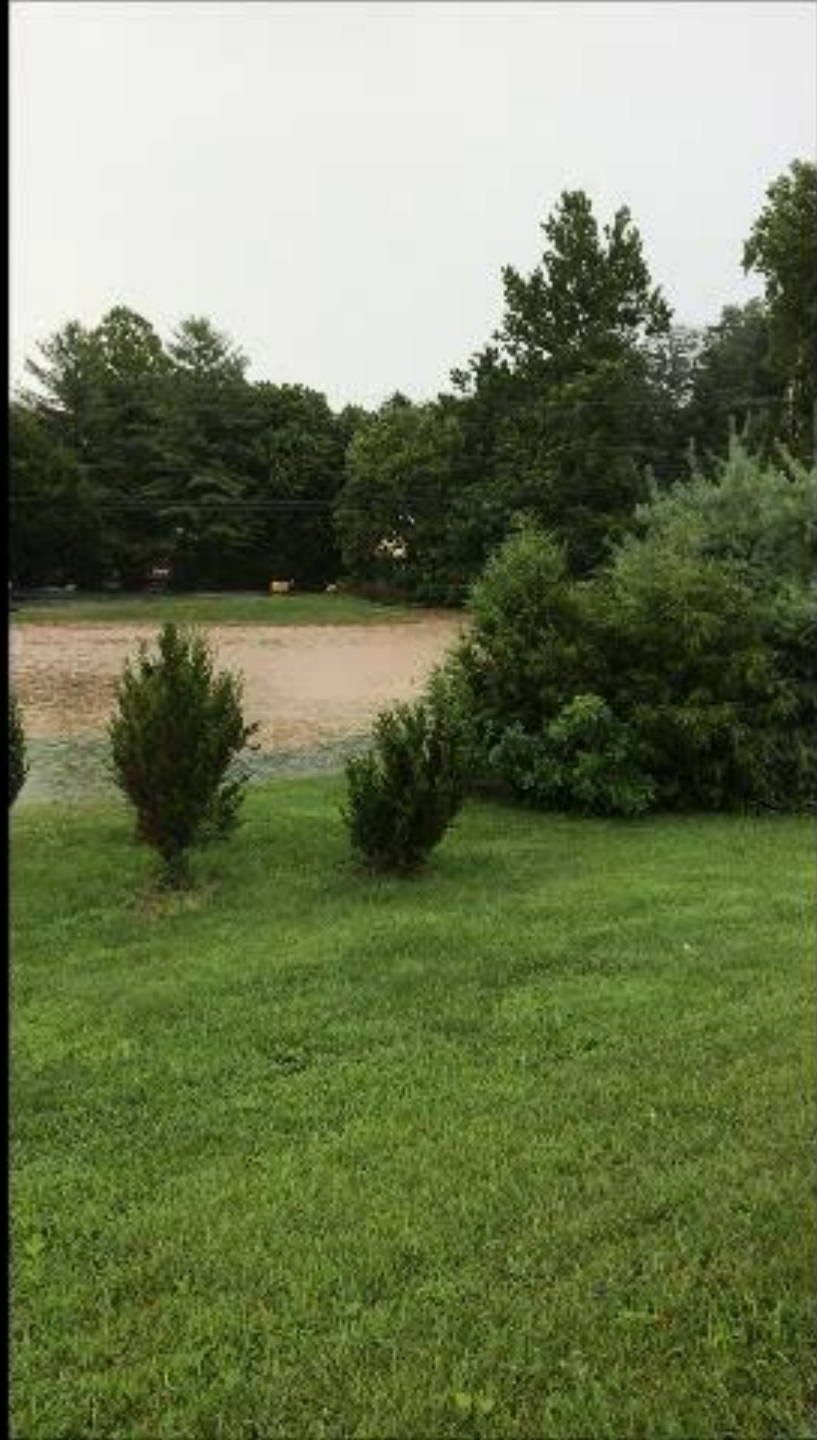
Peaks	Precip. (in.)	Start Time		End Time
6-min	0.44	5:52 PM	-	5:58 PM
12-min	0.77	5:34 PM	-	5:46 PM
18-min	1.17	5:40 PM	-	5:58 PM
24-min	1.54	5:34 PM	-	5:58 PM
30-min	1.83	5:34 PM	-	6:04 PM
60-min	2.75	5:34 PM	-	6:34 PM
120-min	4.03	5:34 PM	-	7:34 PM

NOAA Reference	Avg Rec. Int. (years)	Range (in)
5-min	5	0.423-0.52
10-min	10	0.752-0.924
15-min	25	1.07-1.31
30-min	25	1.57-1.94
60-min	50	2.33-2.89
120-min	100	3.26-4.11

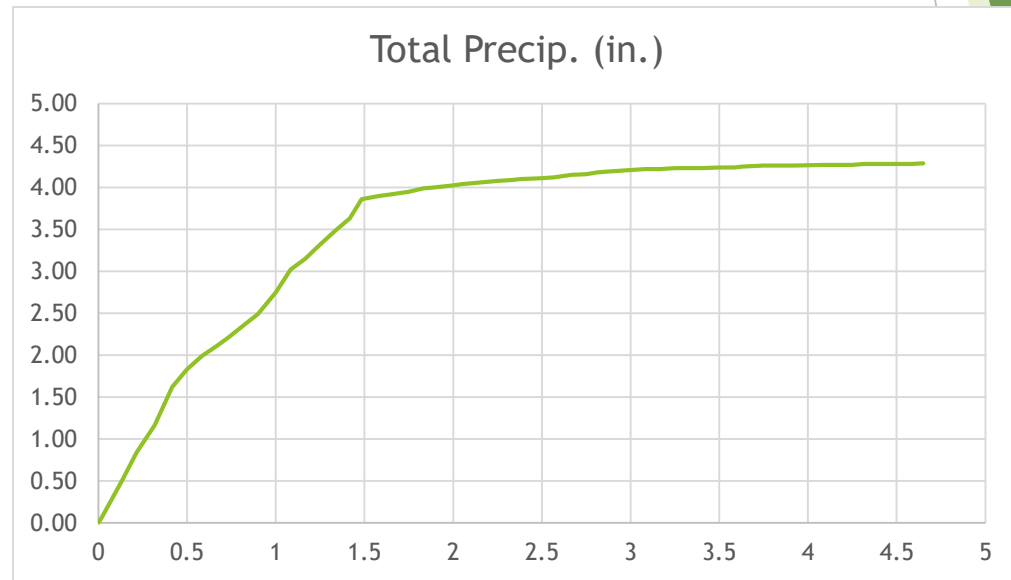
Source: Weather Underground
 KMDWESTM38 Gage
 Compiled: CLSI

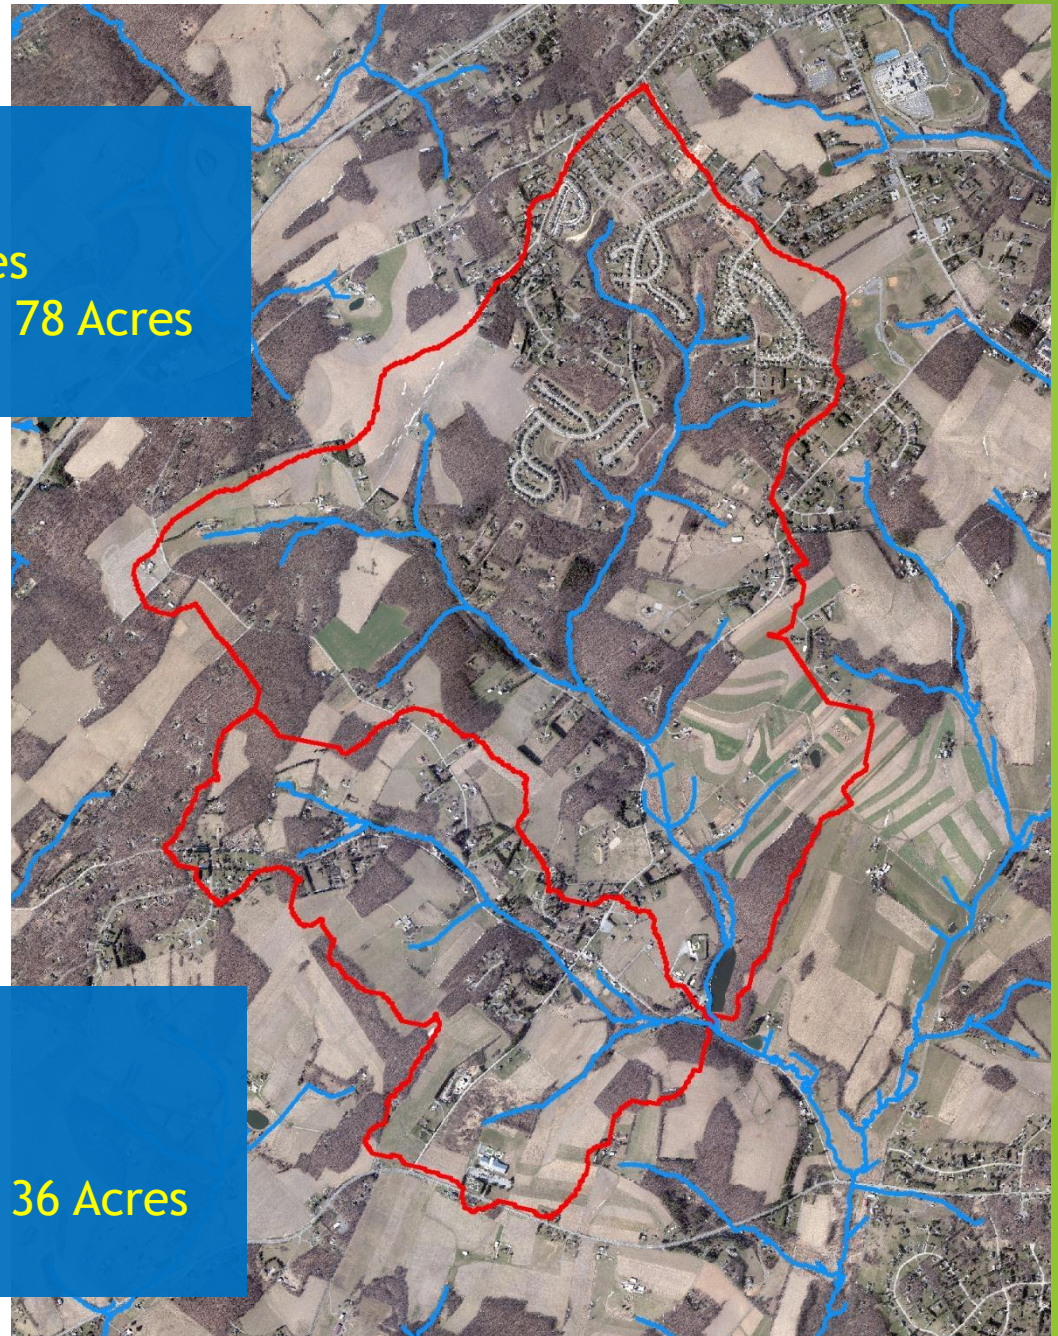
Mainstem:

Drainage Area: 2.53 sq.mi.

Impervious Area: 105.5 Acres

Untreated Impervious Area: 78 Acres

Use Class III Watershed

Tributary:

Drainage Area: 1.07 sq.mi.

Impervious Area: 38.5 Acres

Untreated Impervious Area: 36 Acres

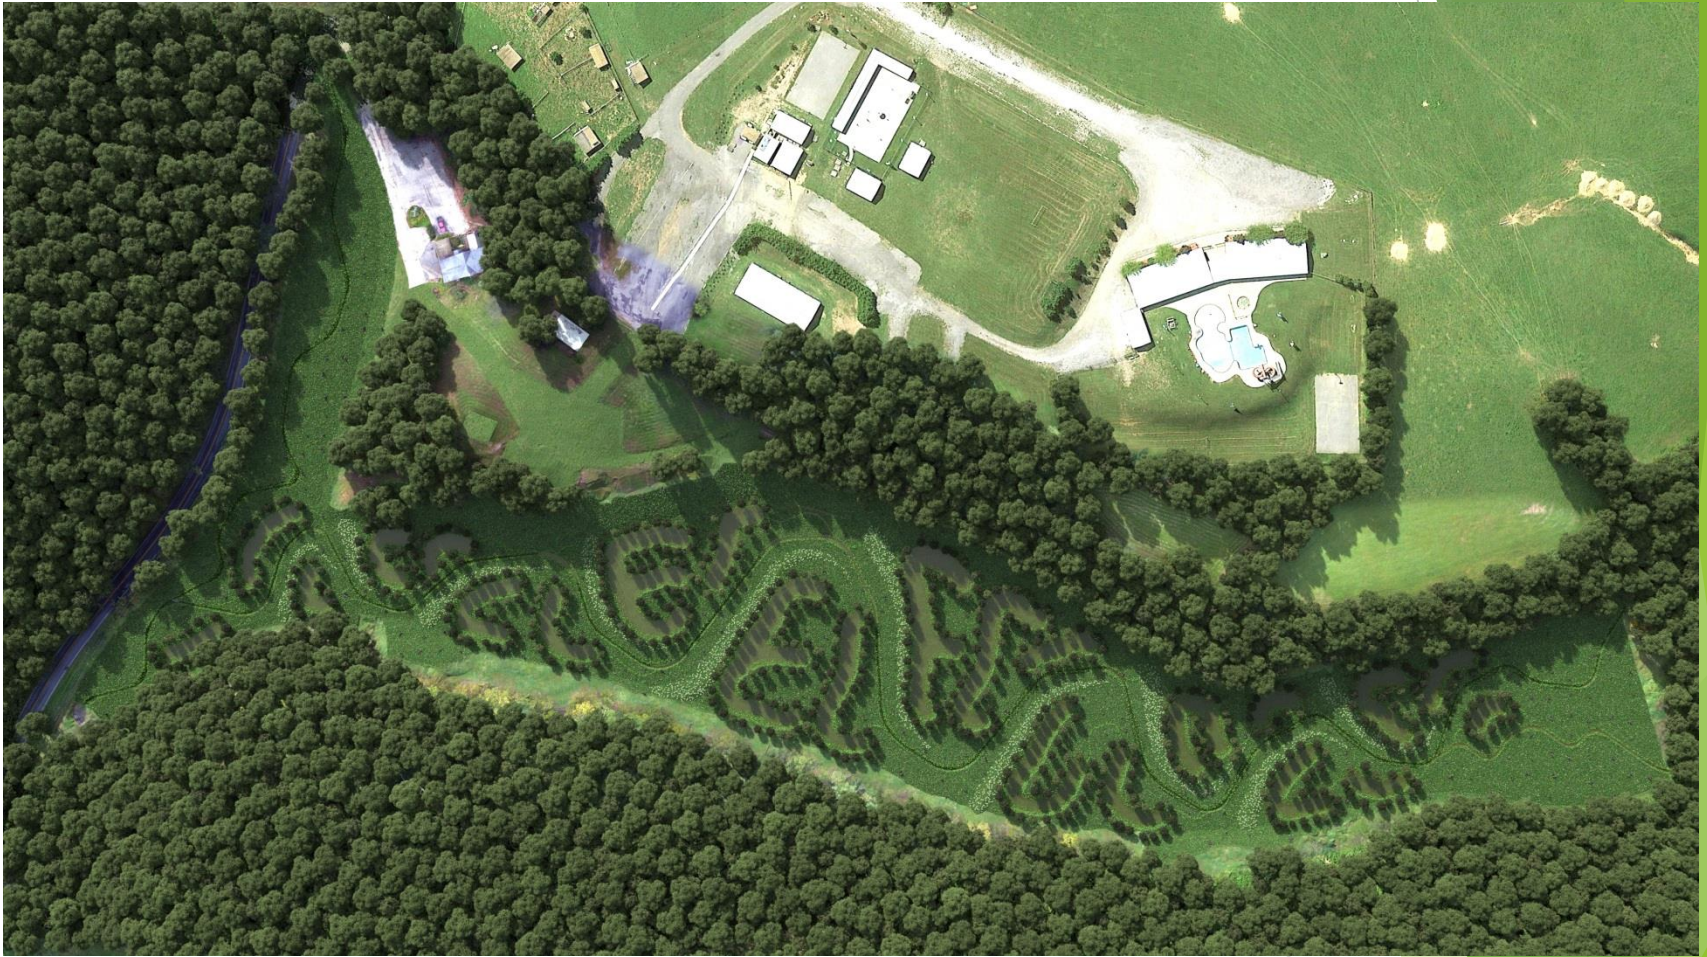
Design Two

Design One

- ▶ Restore the stream on one side of the valley, and provide SWM treatment area on other side.
- ▶ 1000-foot long flood plain berm to separate the two areas.

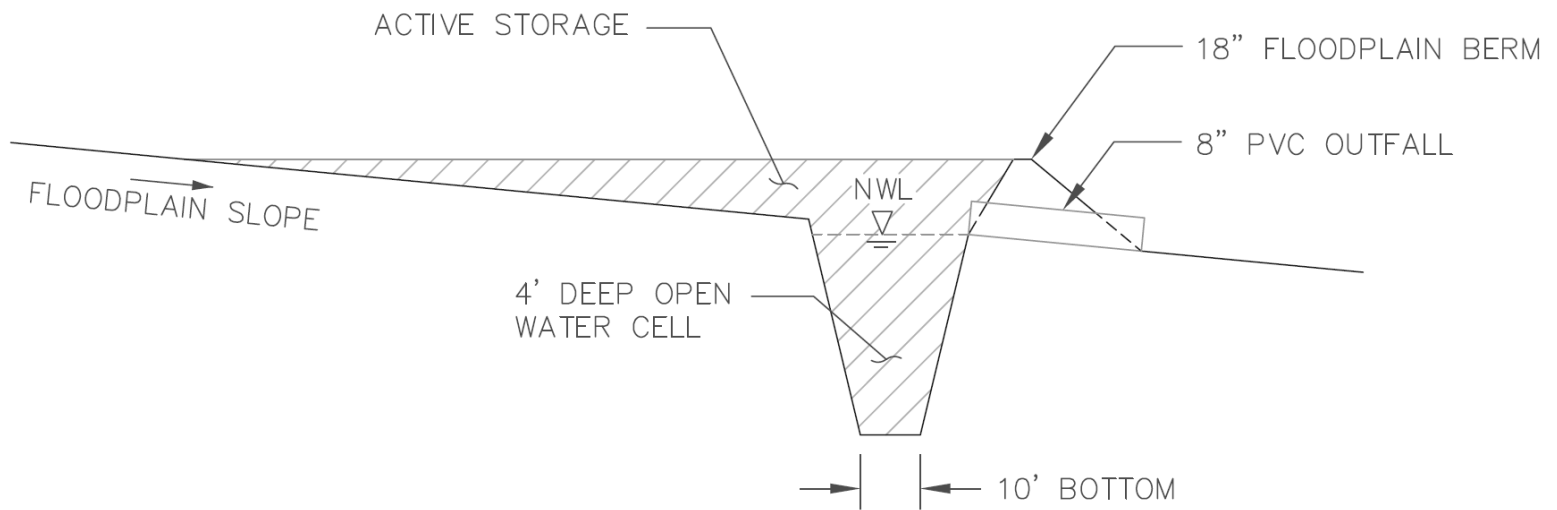
STORMWATER WETLANDS

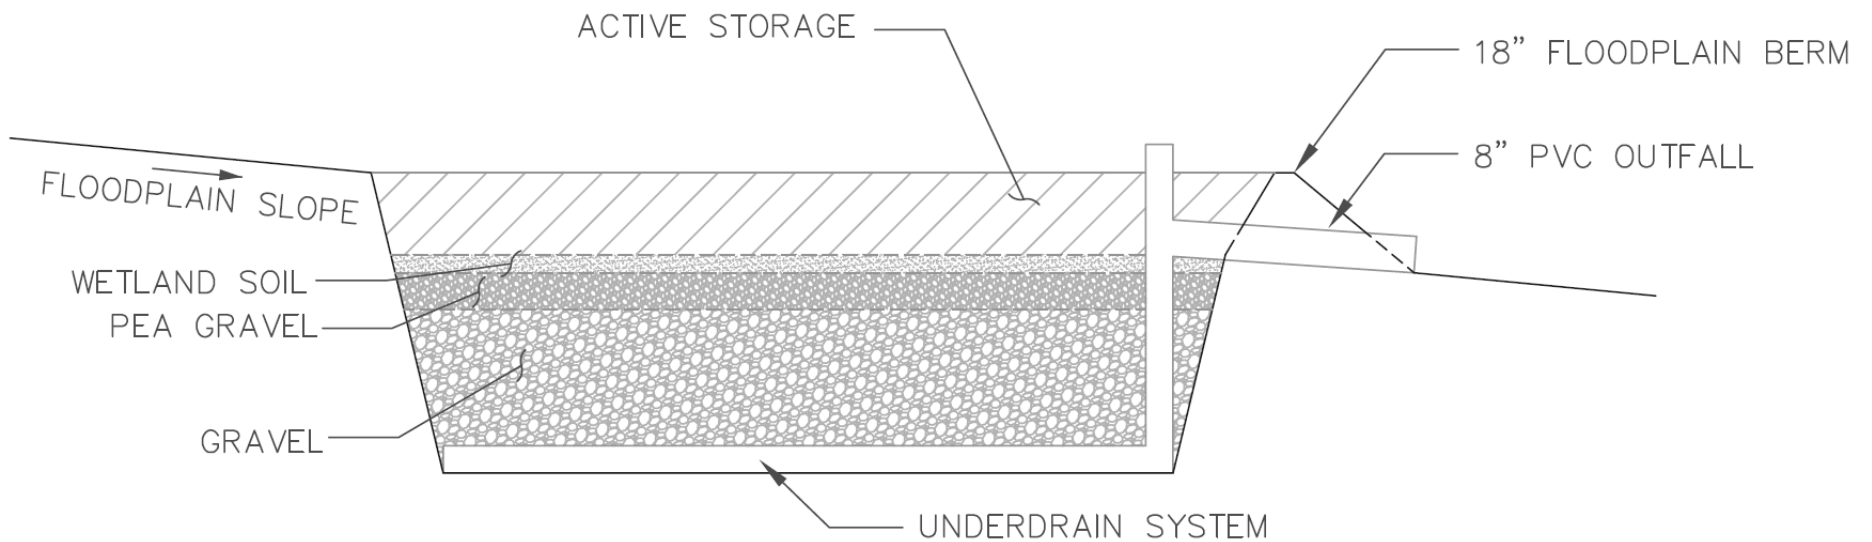
SUBMERGED GRAVEL WETLANDS

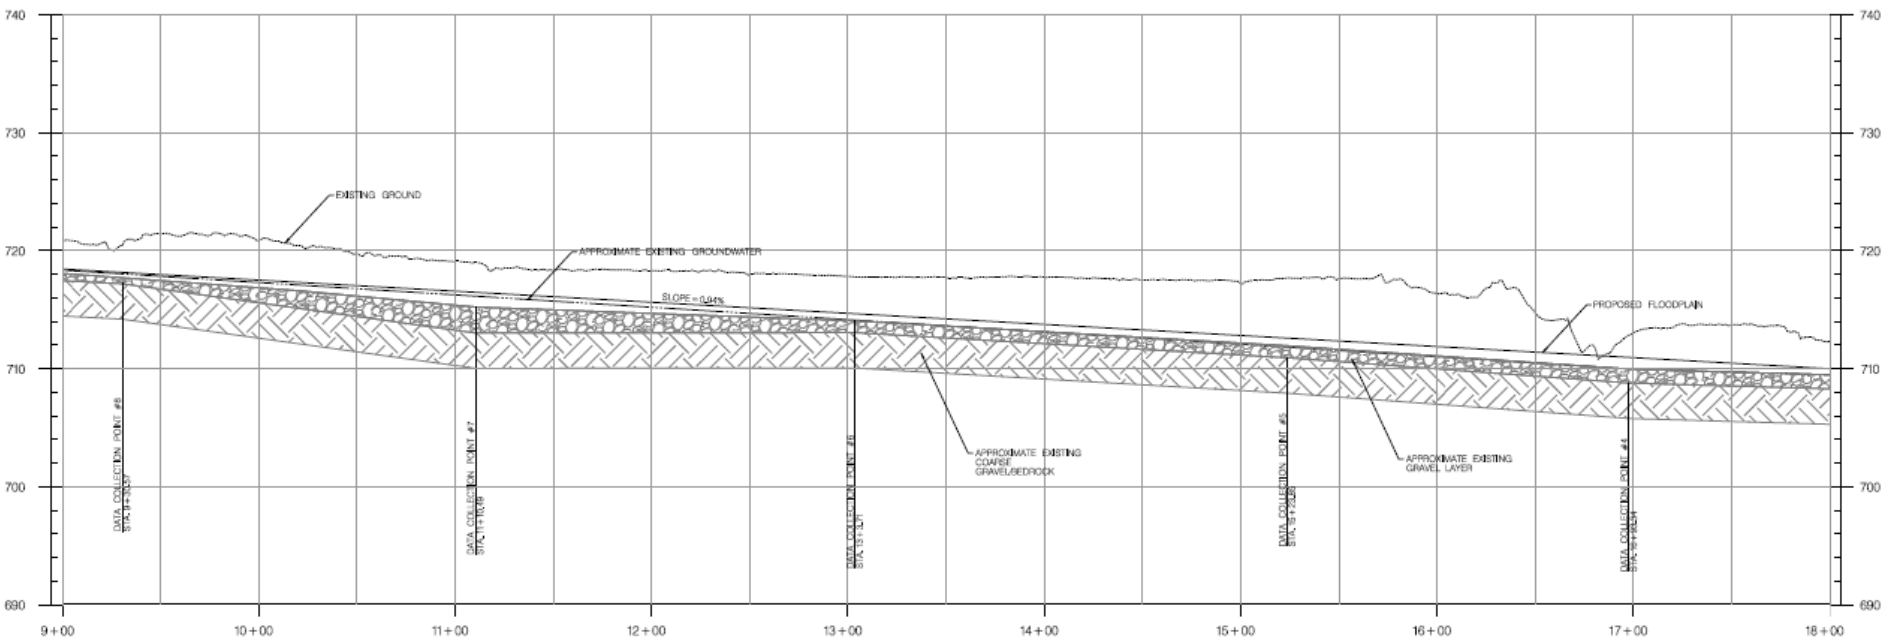
**FLOODPLAIN
BASELINE PROFILE**
SCALE: 1" = 30' HORZ.
1" = 5' VERT.
