PINEY RUN RESERVOIR Environmental Advisory Council

October 21, 2020

Piney Run Dam

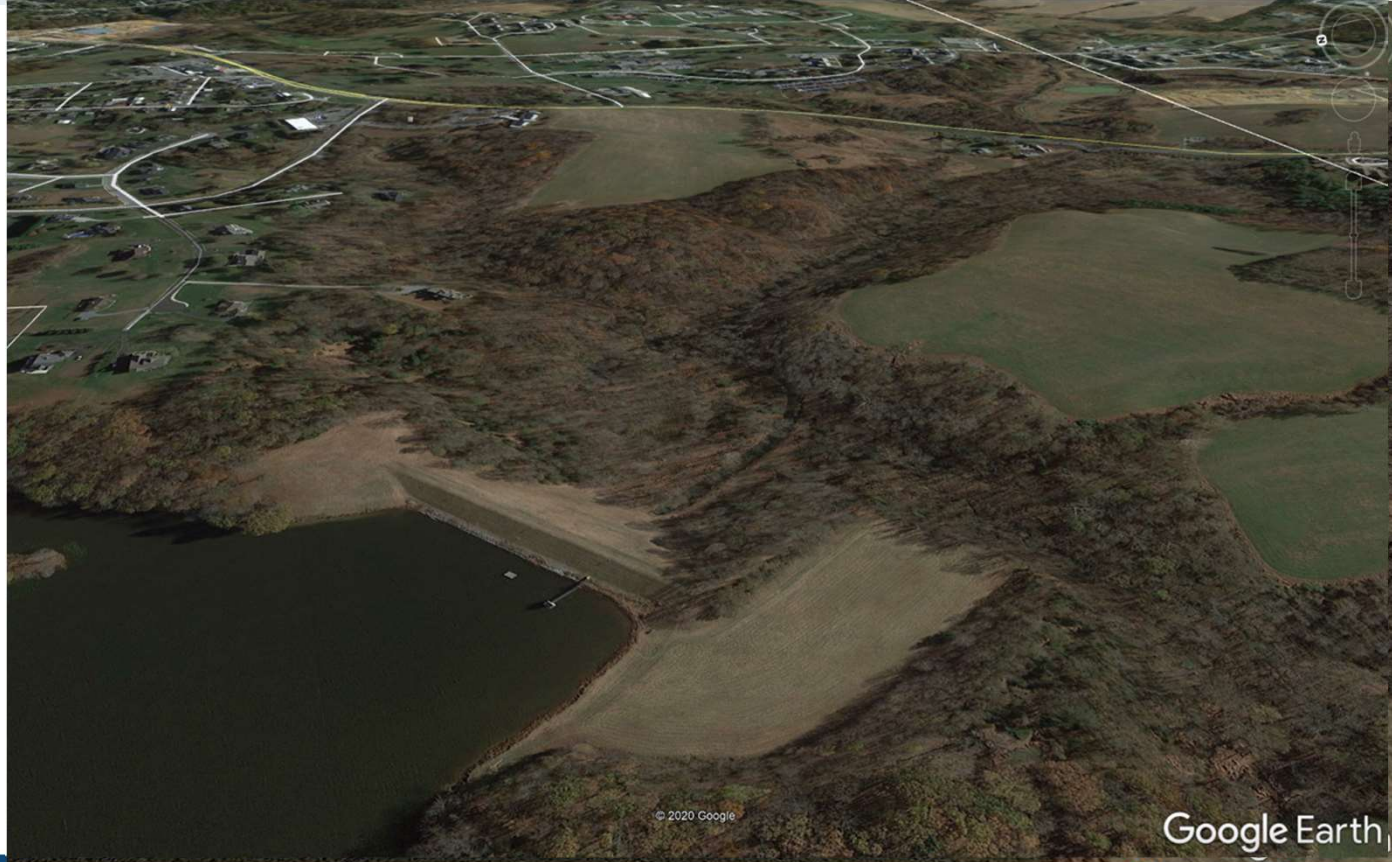
- Completed 1974
- 73 feet tall, 600 feet long
- 10.6 square mile watershed
- Reservoir:
 - 290 Acres
 - 54 foot maximum depth
 - Normal Capacity:
1.7 billion gallons
- Classified as High Hazard

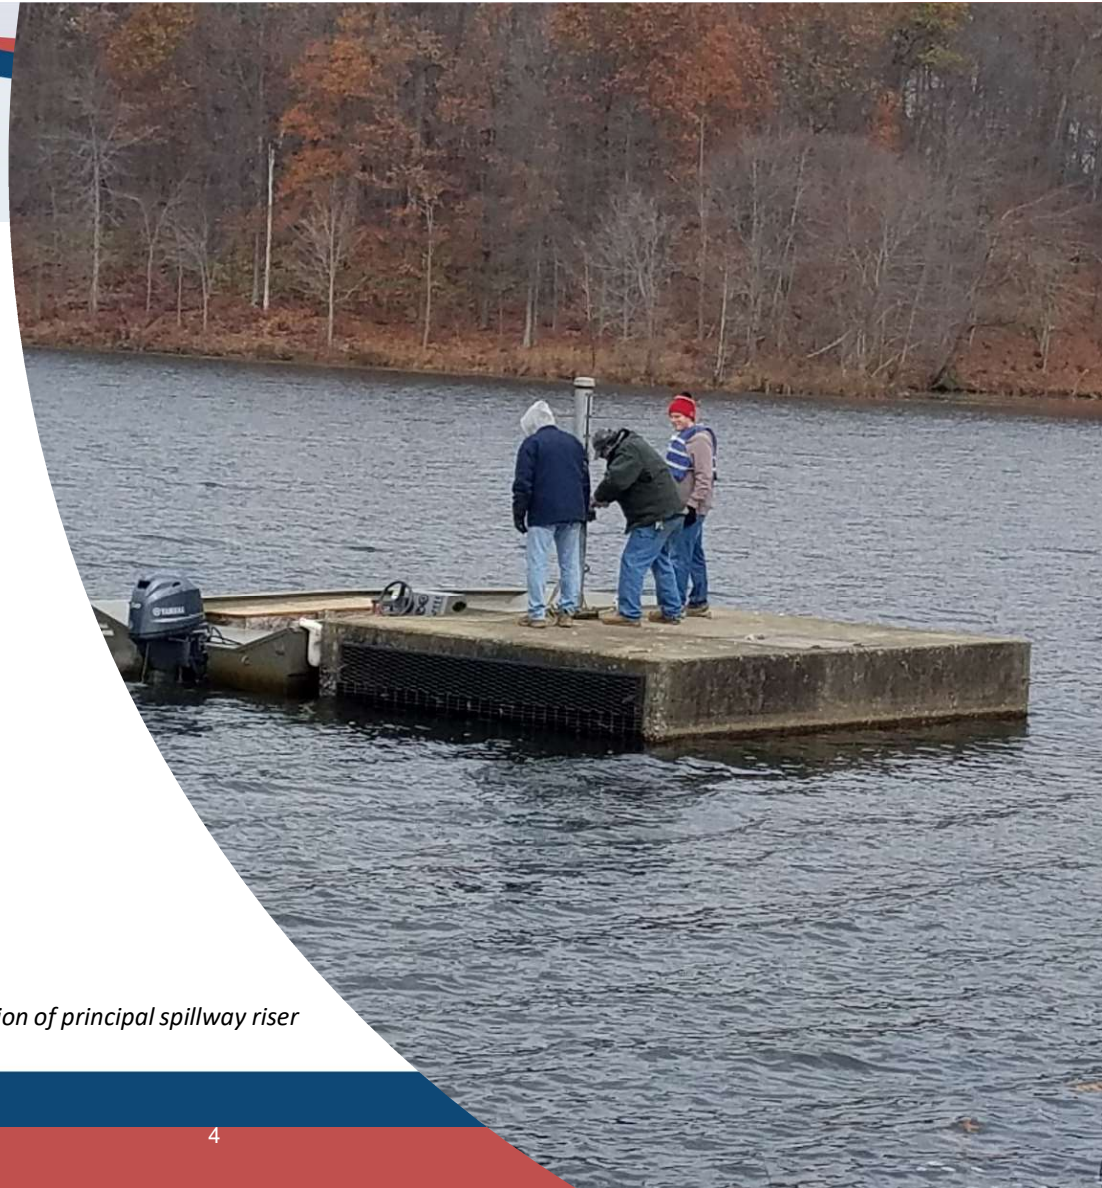
Inspection of principal spillway riser

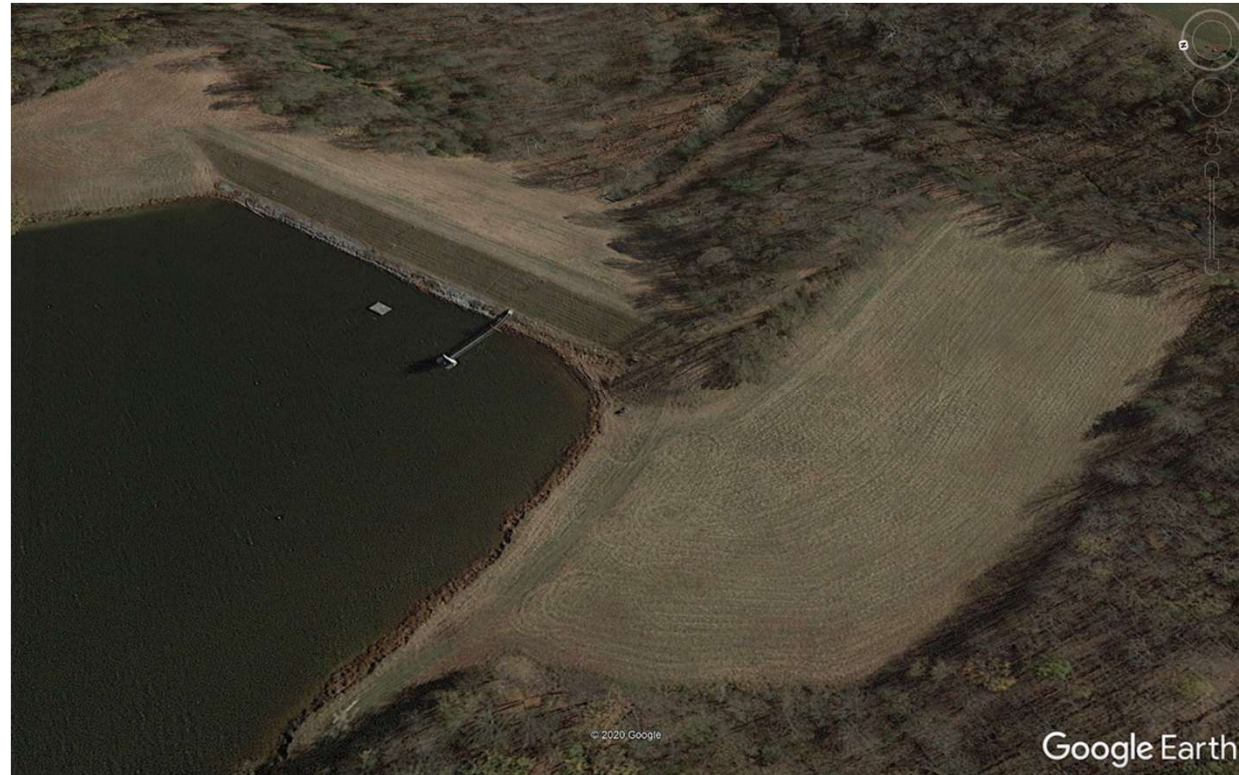
Auxiliary Spillway Capacity

- PMF storm – Overtops dam by 6 feet
- Potential Solutions
 - Wider Auxiliary Spillway
 - Higher Dam
 - Secondary Spillway

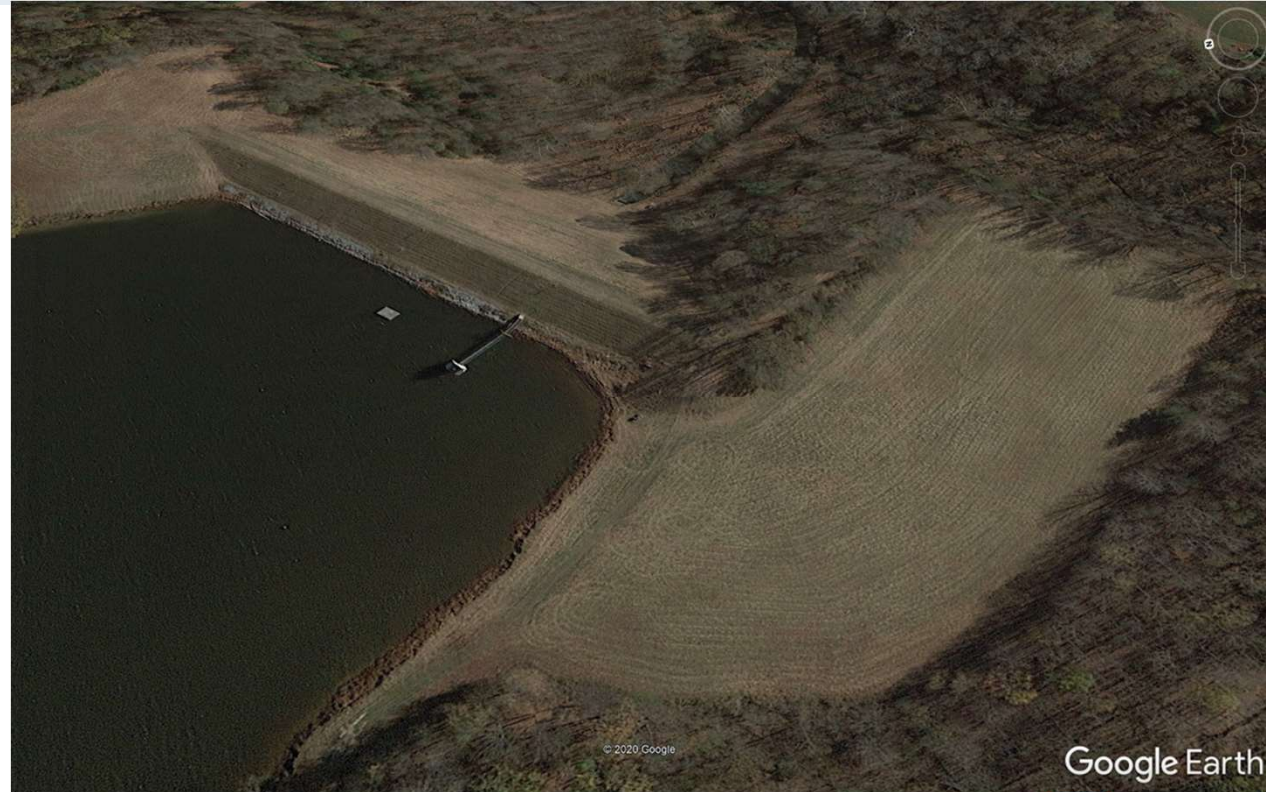
Auxiliary Spillway Erodibility

- Forces on the spillway during the PMF are potentially enough to erode the weathered rock.
- Erosion of the spillway could lead to a failure.
- Potential solutions
 - Concrete protection
 - Secant pile wall
